Winnetka Park District

Elder and Centennial  
Park and Beach Project Presentation

October 13, 2021

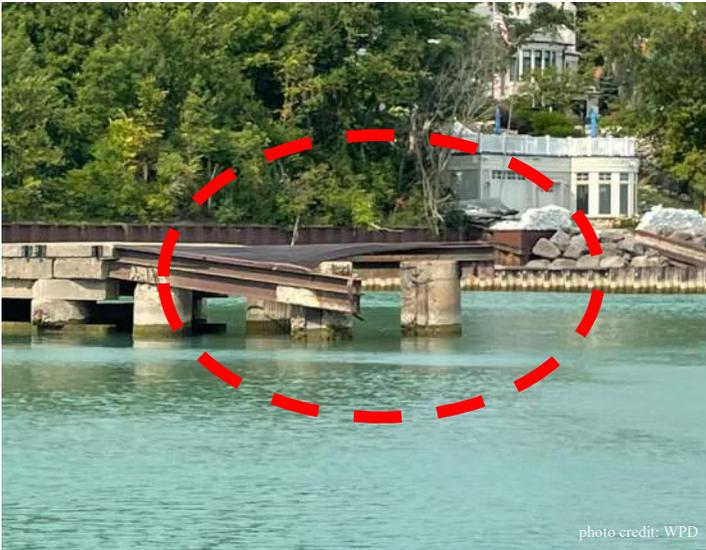
Damaged pier

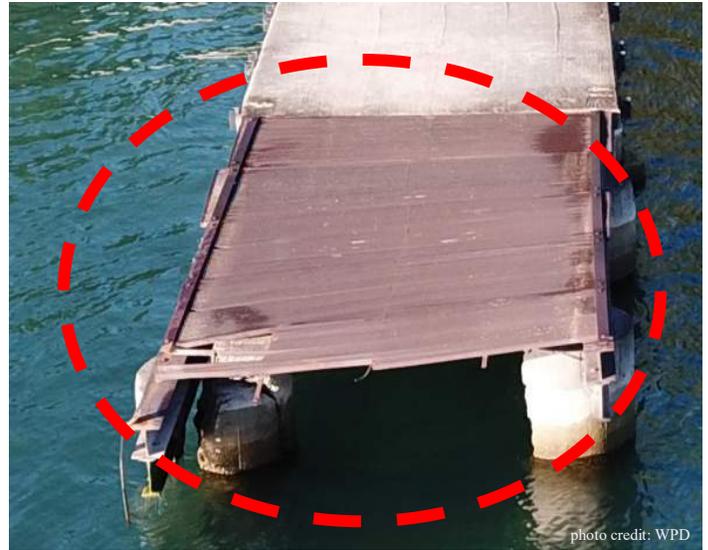
Damaged pier

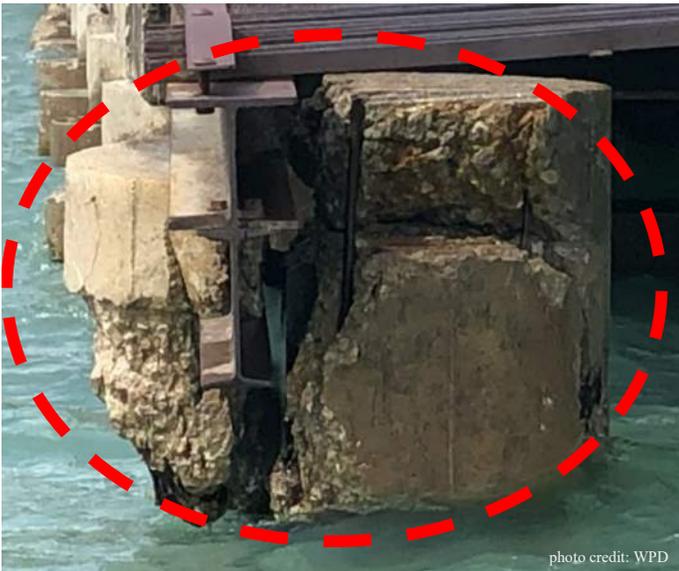
Damaged pier

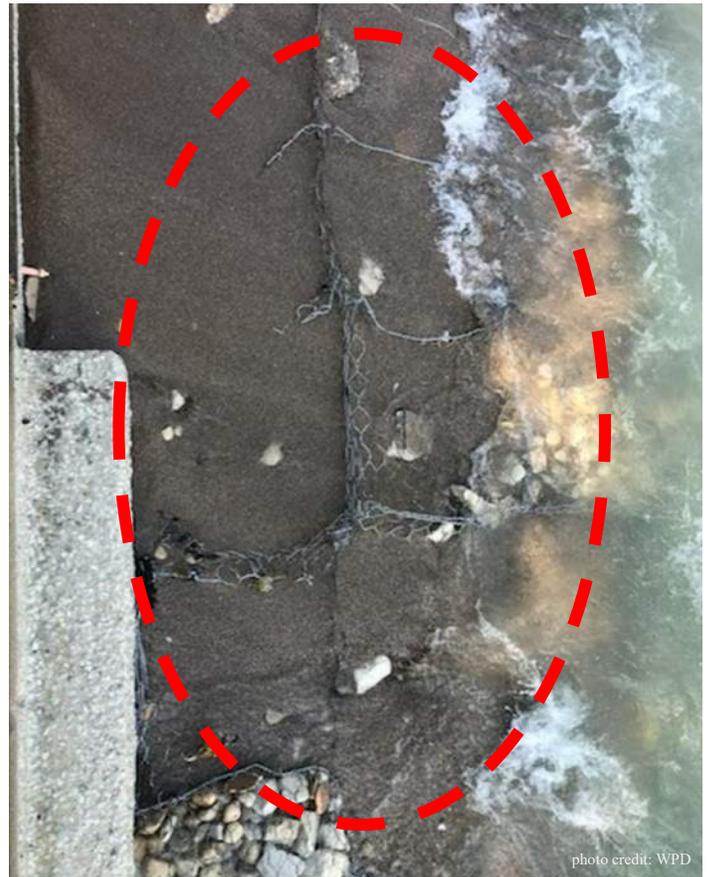
Damaged gabion baskets

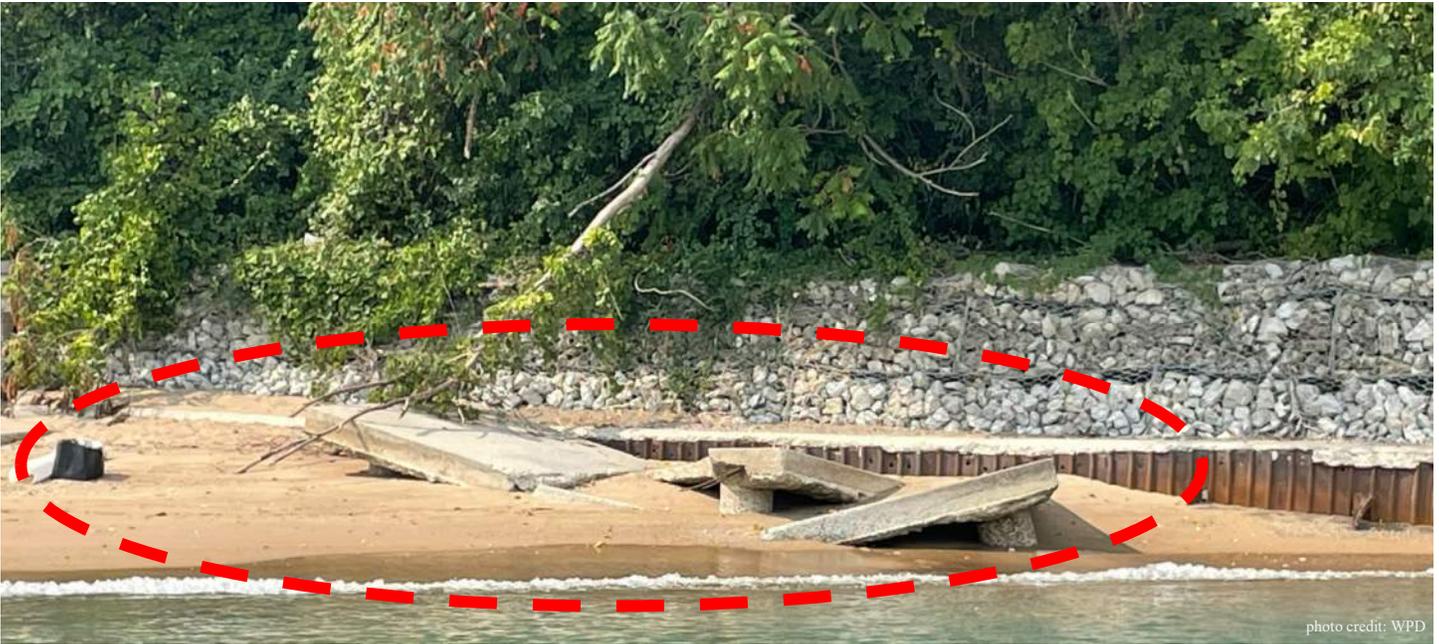
Damaged kayak storage rack foundations

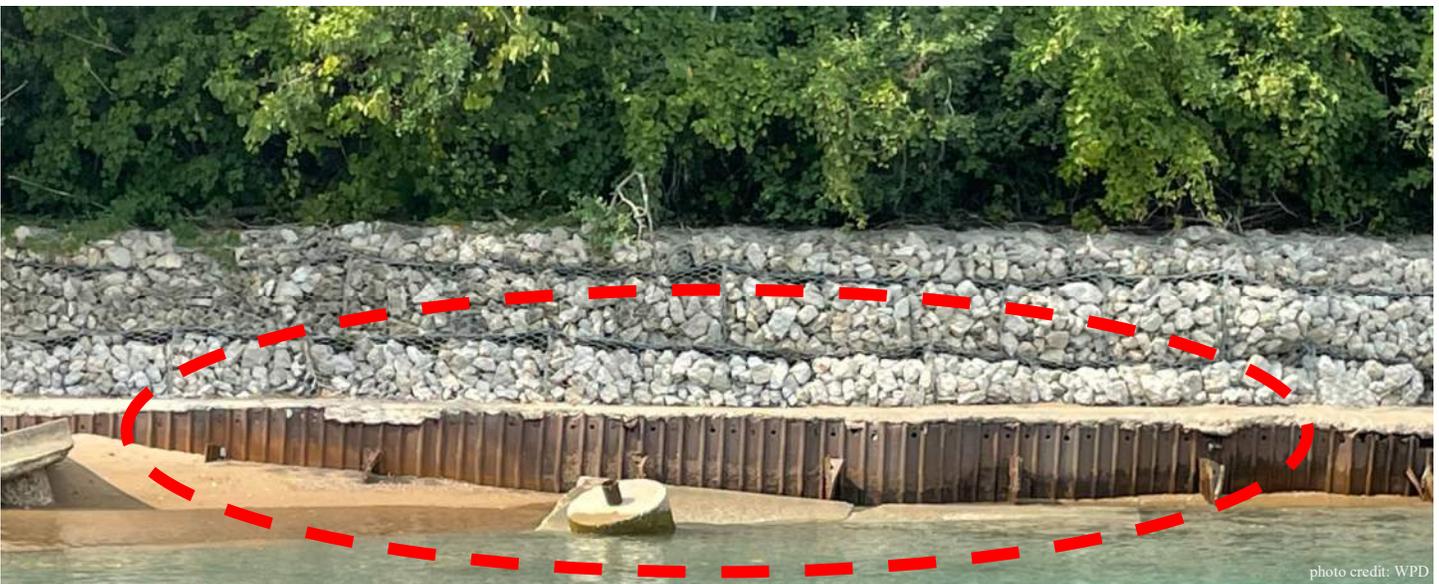
Damaged steel sea wall

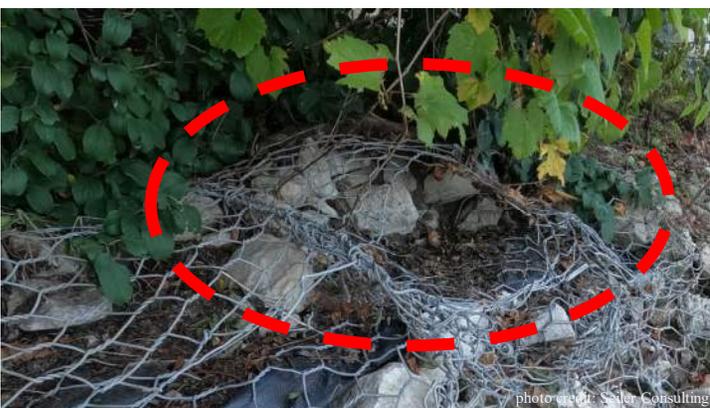
Damaged gabion basket

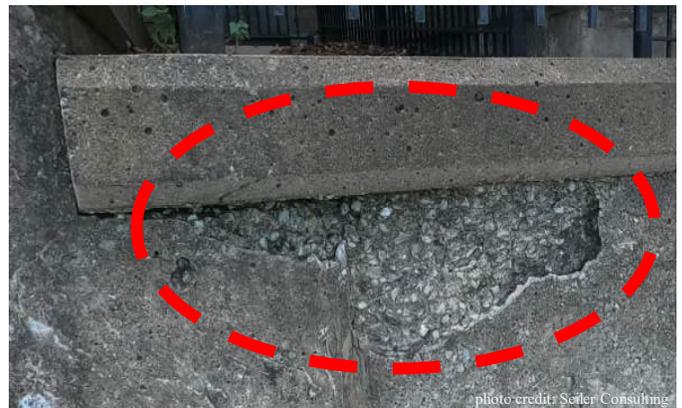
Spalling concrete sea wall

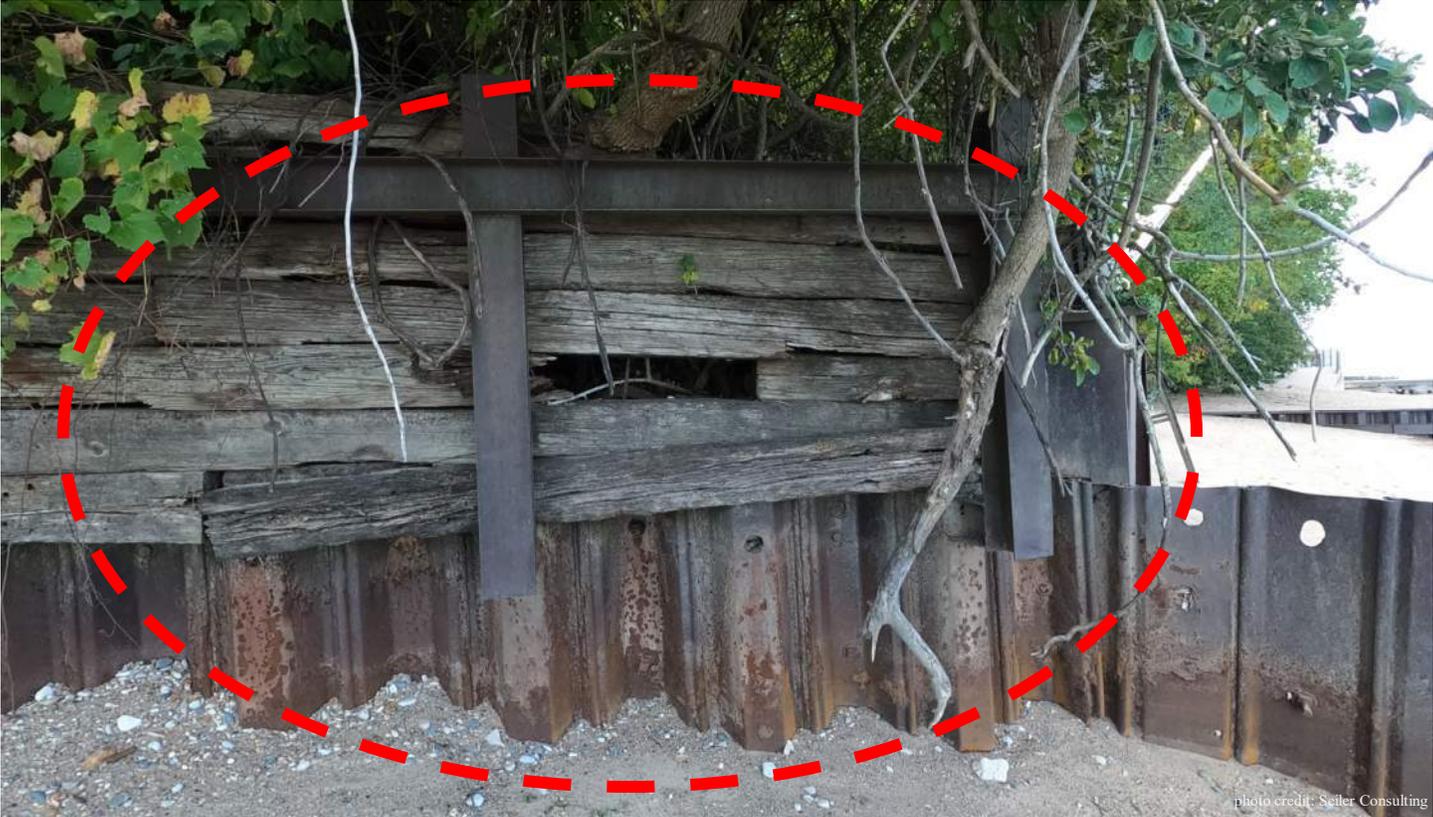
Damaged sea wall

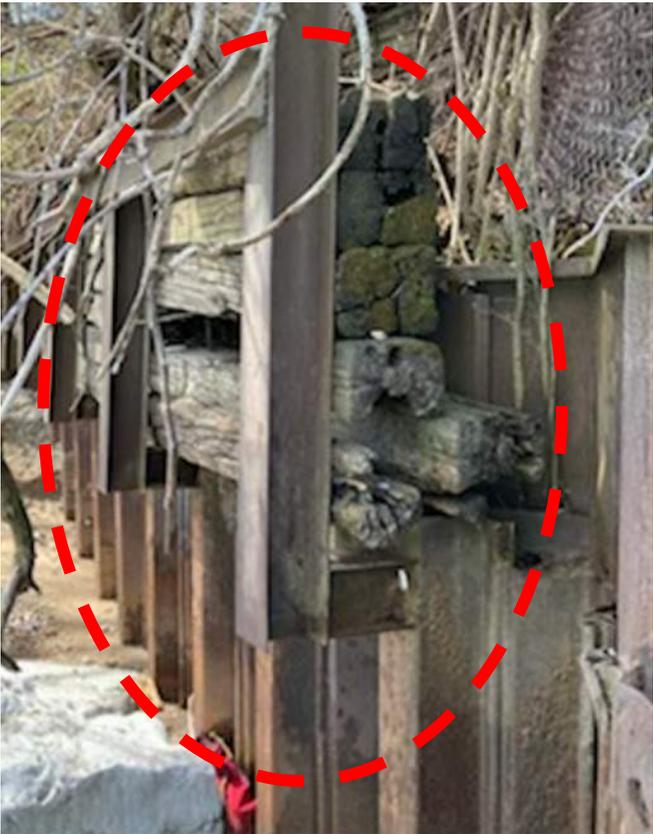
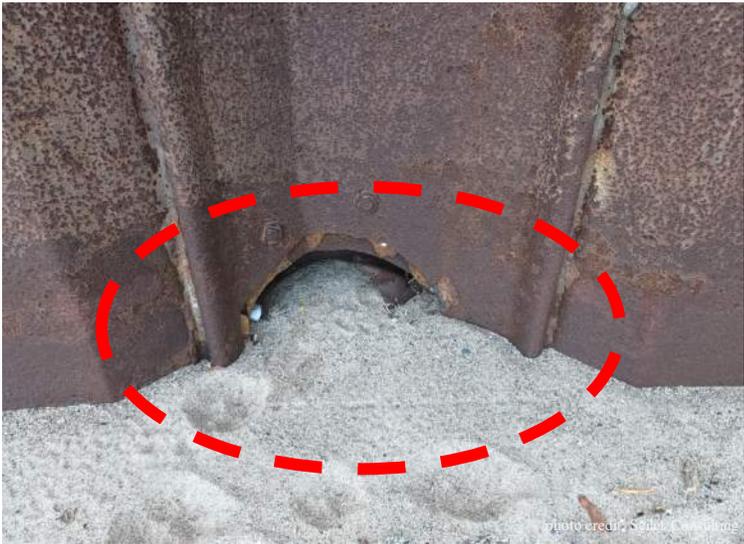
Damaged sea wall

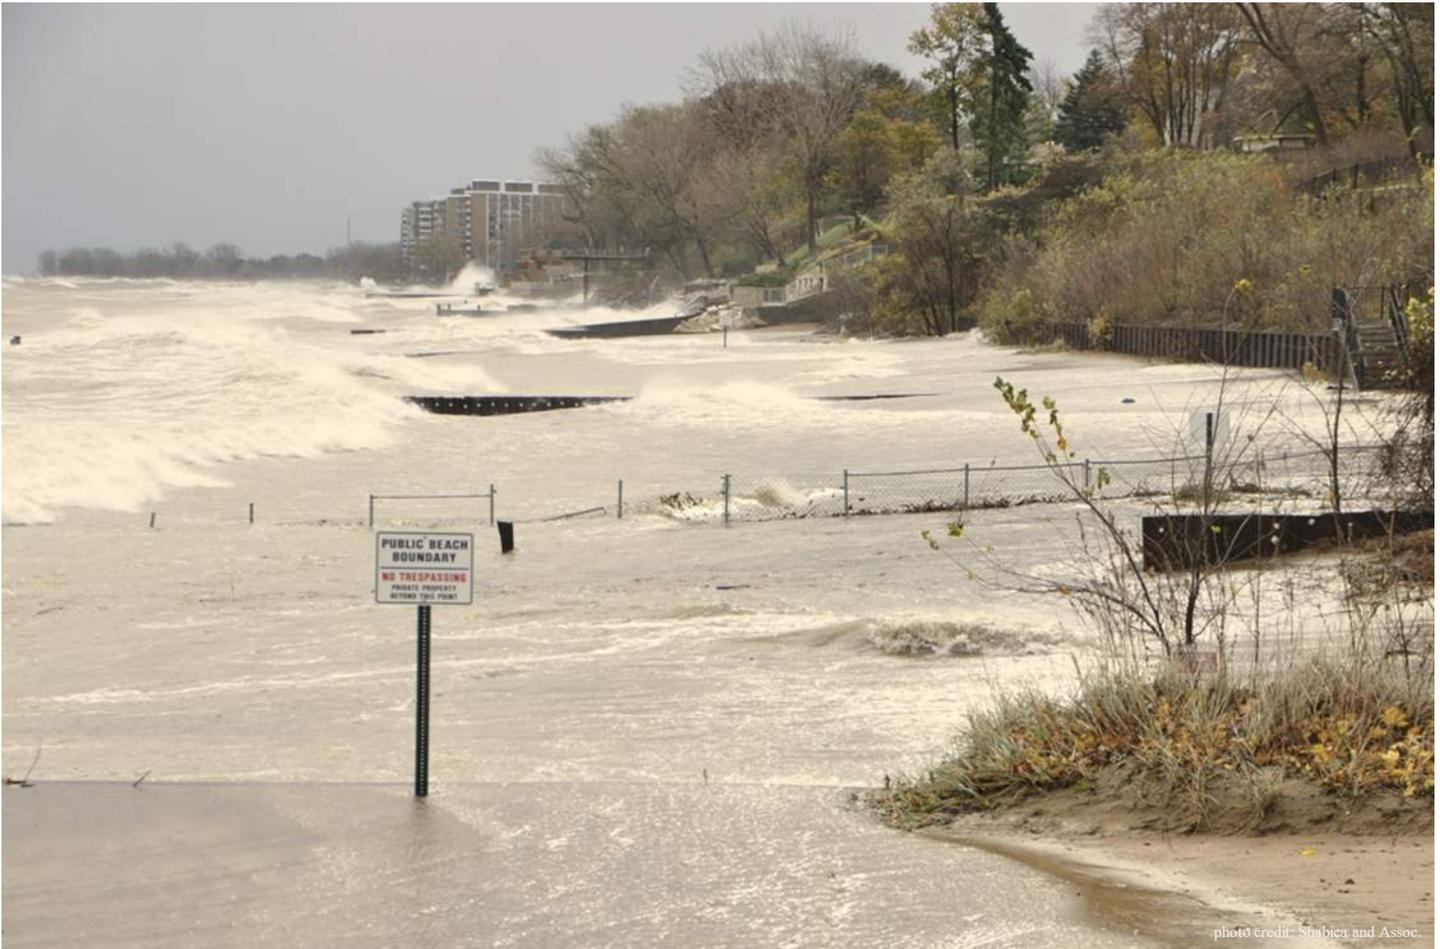
High water and extreme weather conditions have damaged existing infrastructure, causing beach and bluff erosion

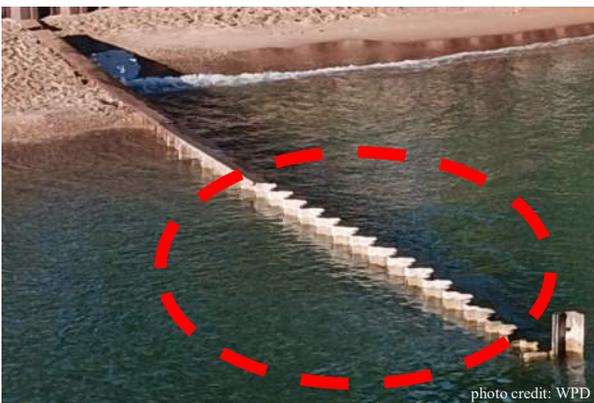
Damaged groin

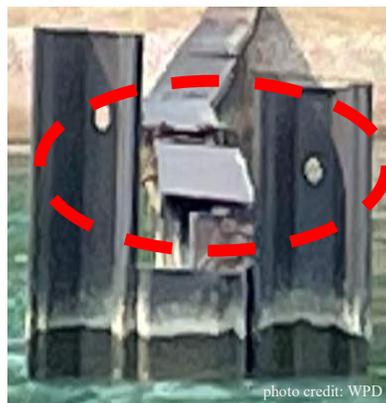
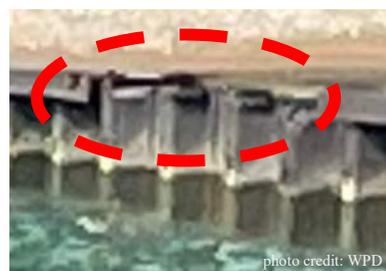
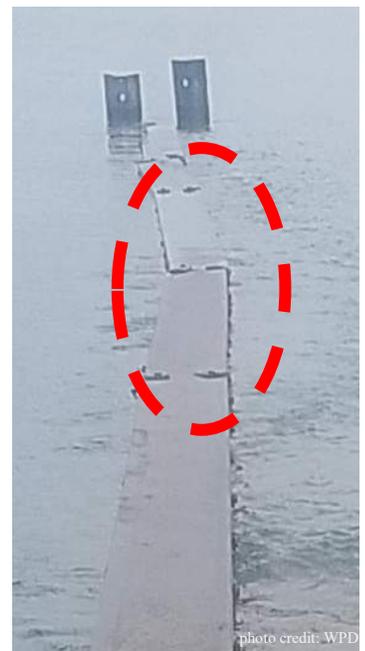
Damaged groin

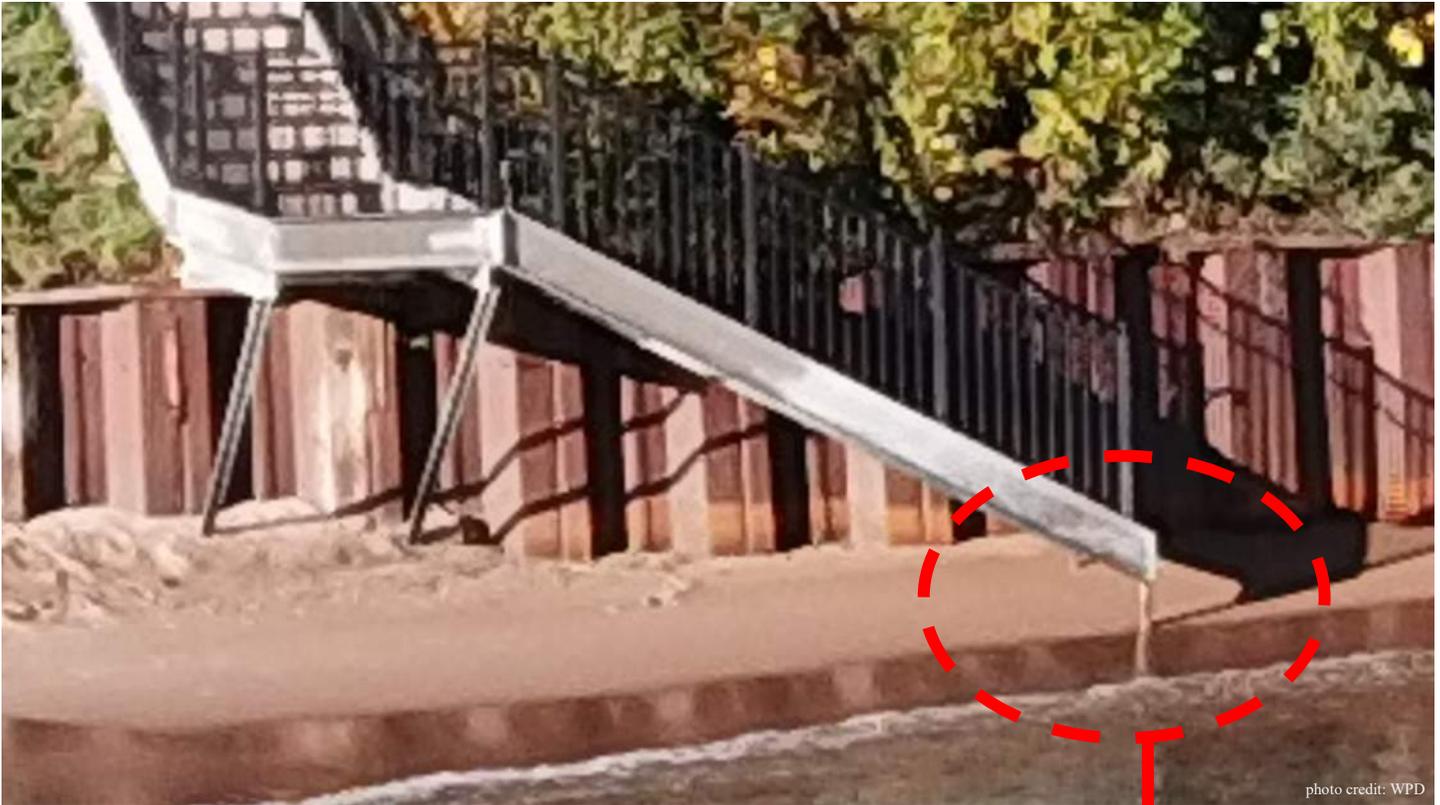
Beach erosion in 2020 meant stairs ended 24" above the beach level

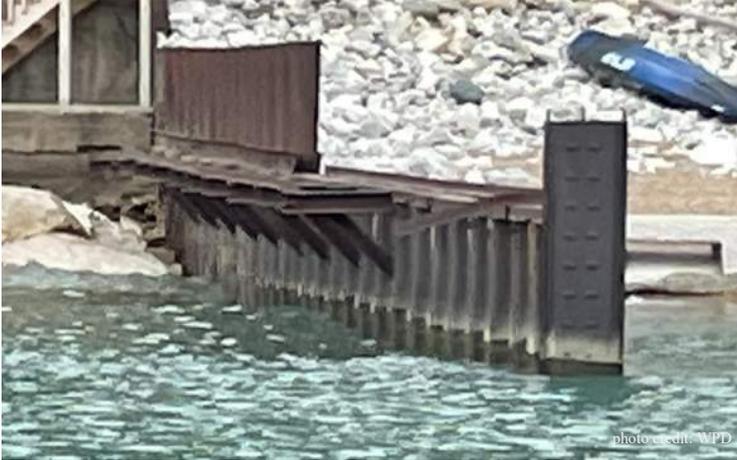
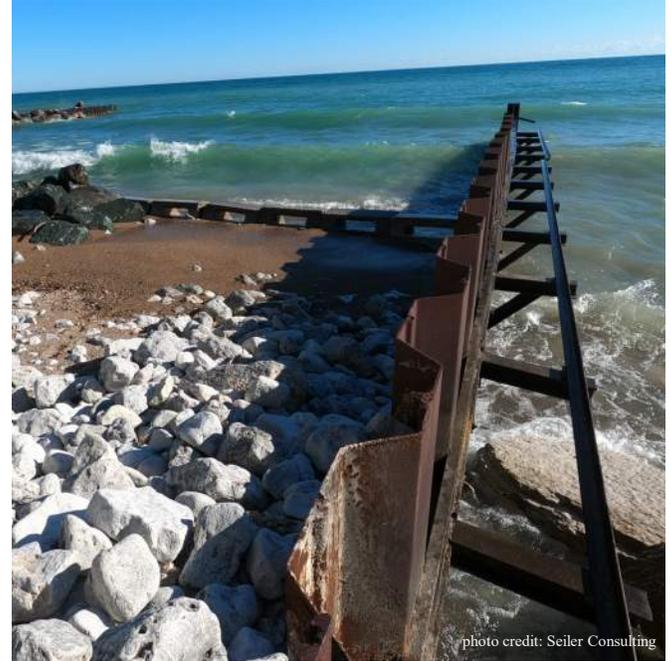
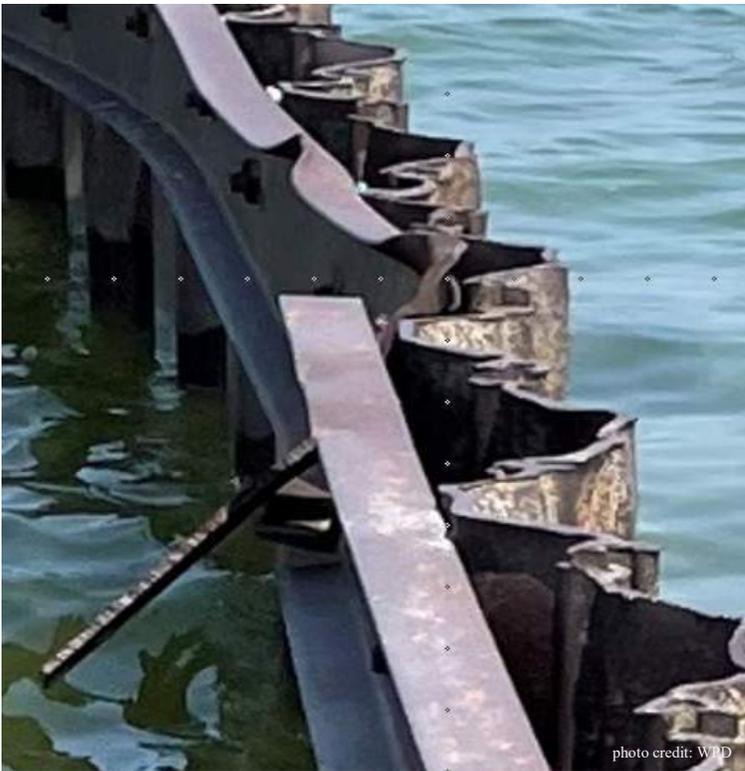
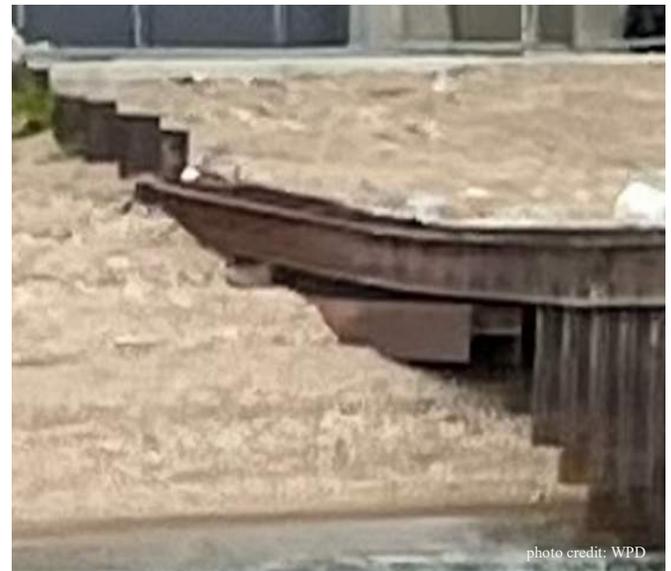
Concern #2 – Physical Hazards

The shoreline to the north and south has hazardous conditions from which the Park District must protect its patrons. Unsafe rock formations, damaged sharp steel groin sections and unmaintained major debris are present in both directions. The Park District seeks to avoid needing to defend themselves should a beach patron, wandering from the beach and encountering one of these items, get injured.

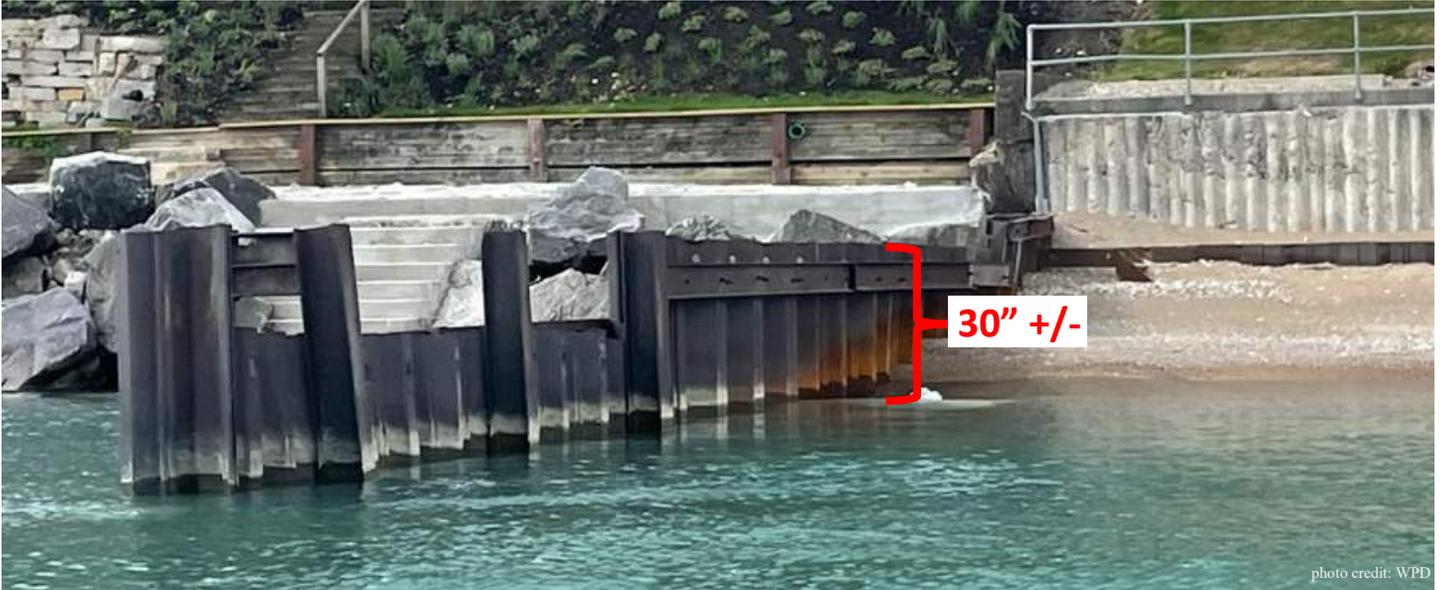
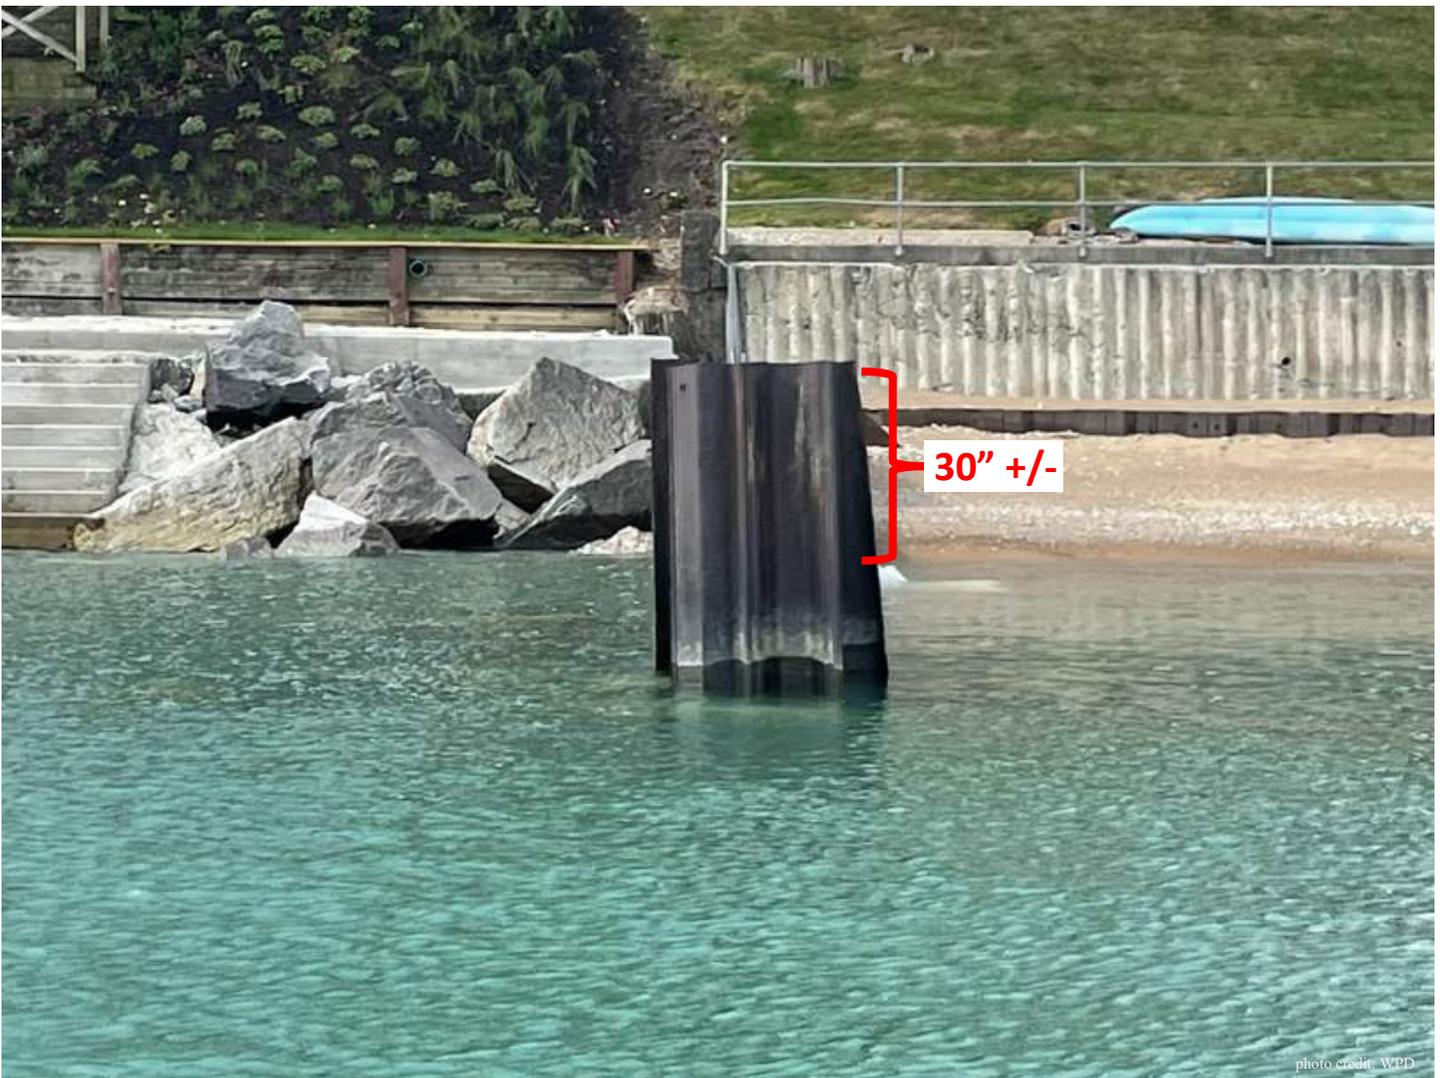
## 141 to 151 Sheridan Road

The top of the groin is approximately 30" above the water line on the north face. This structure blocks pedestrian movement along the shoreline. A pedestrian would need to scale this unsafe structure in order to safely walk the beach below the OHWM.

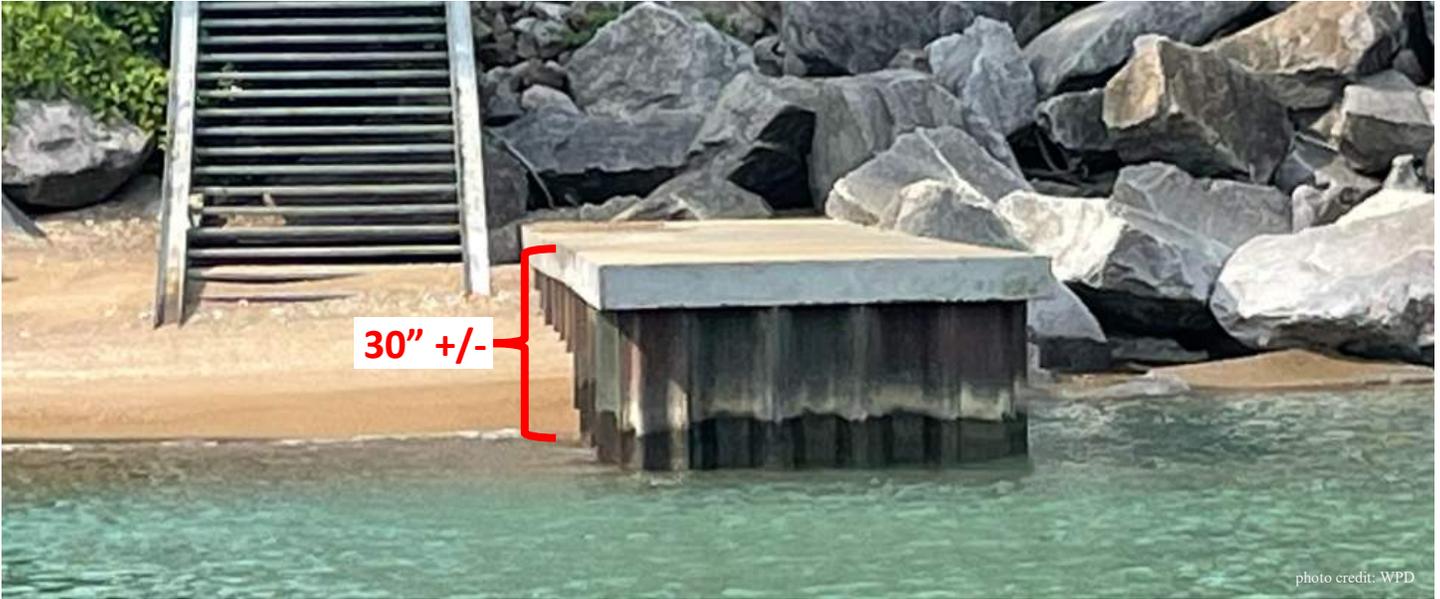
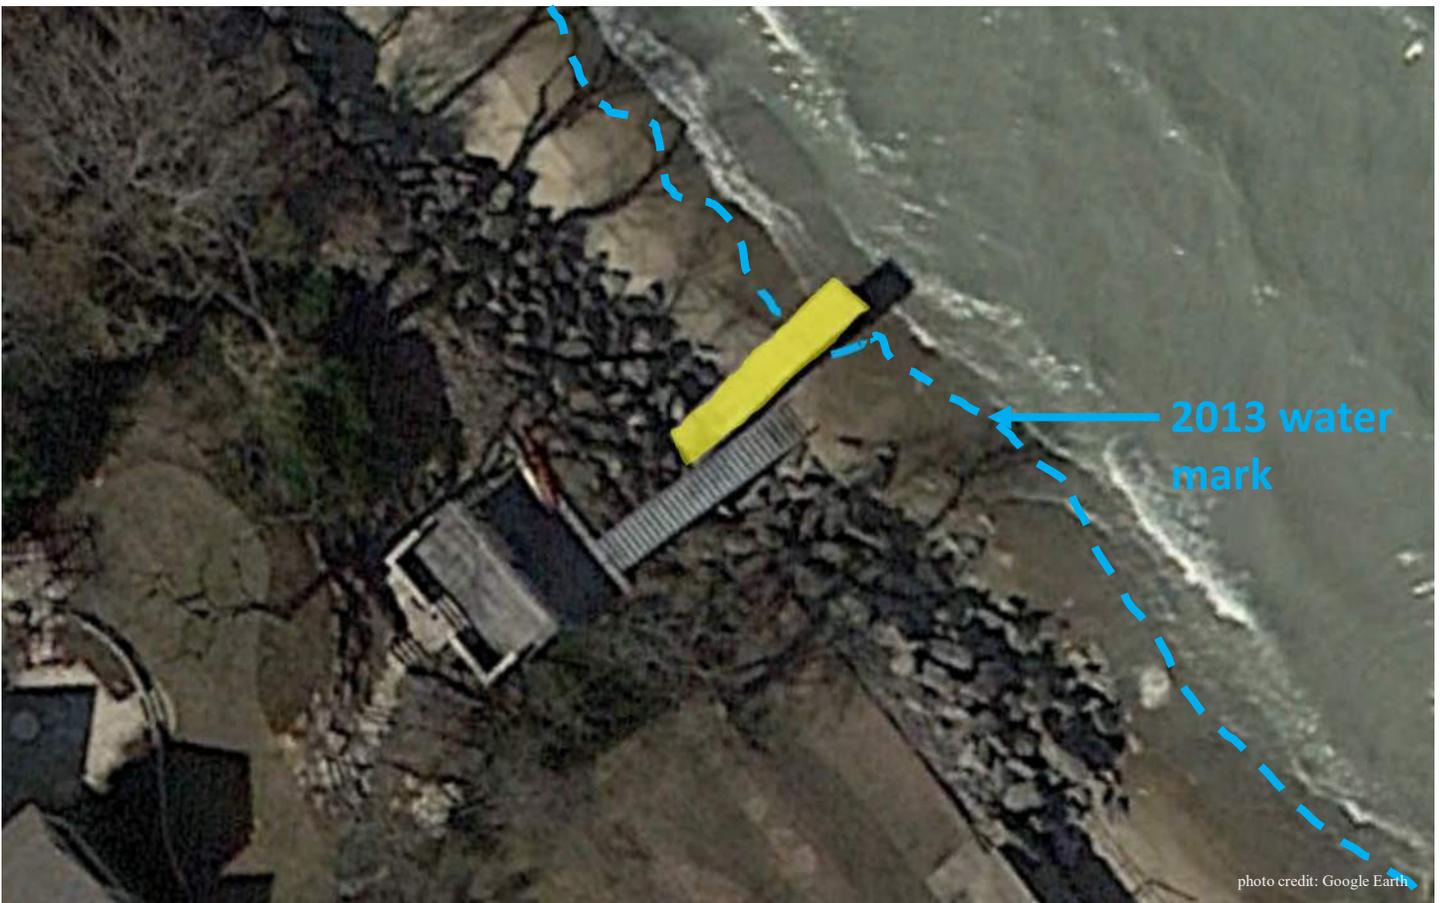
### 159 Sheridan Road

The top of the private pier is approximately 30" above the beach grade at the water line. This structure blocks pedestrian movement along the shoreline. A pedestrian would need to scale this structure in order to safely walk the beach below the OHWM. Furthermore, this structure presents a fall risk for any pedestrian who should attempt to scale it. Even when the lake level was low in 2013, the pier blocked pedestrian movement along the shoreline.

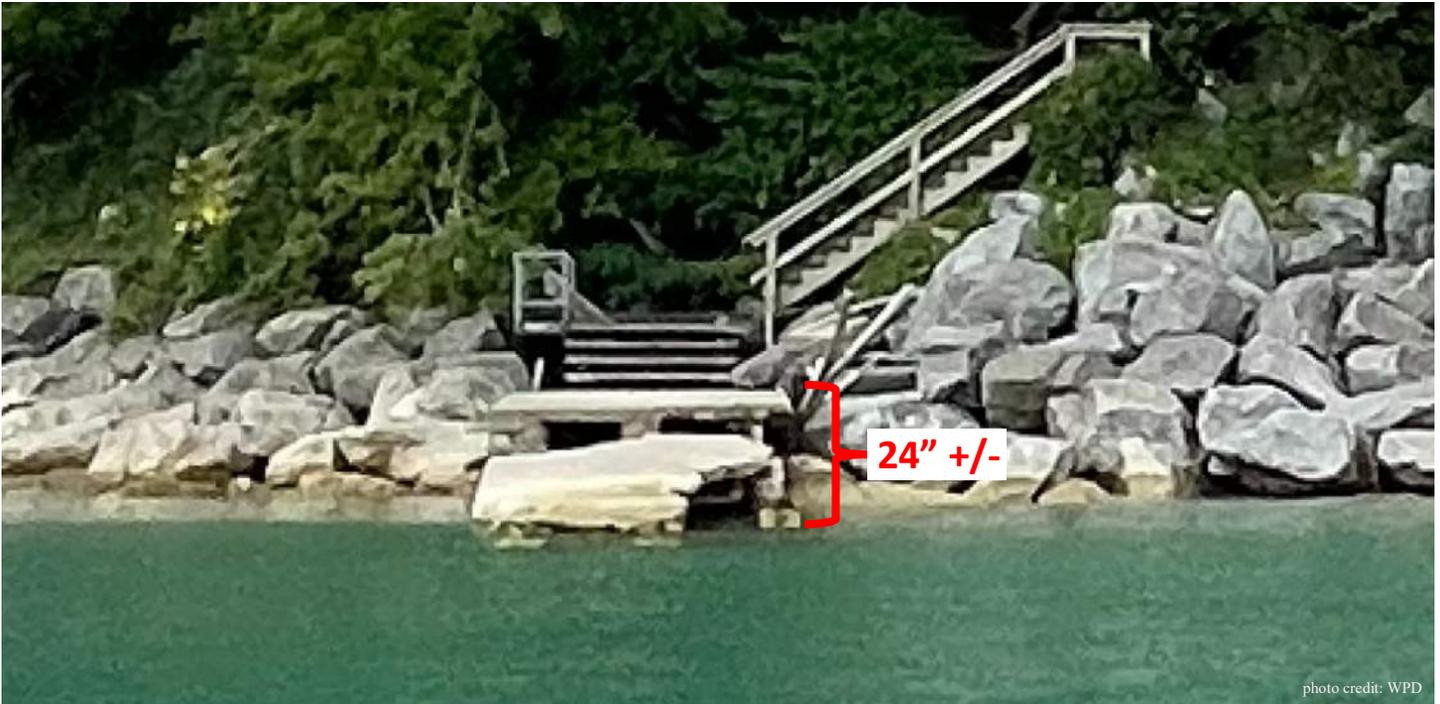
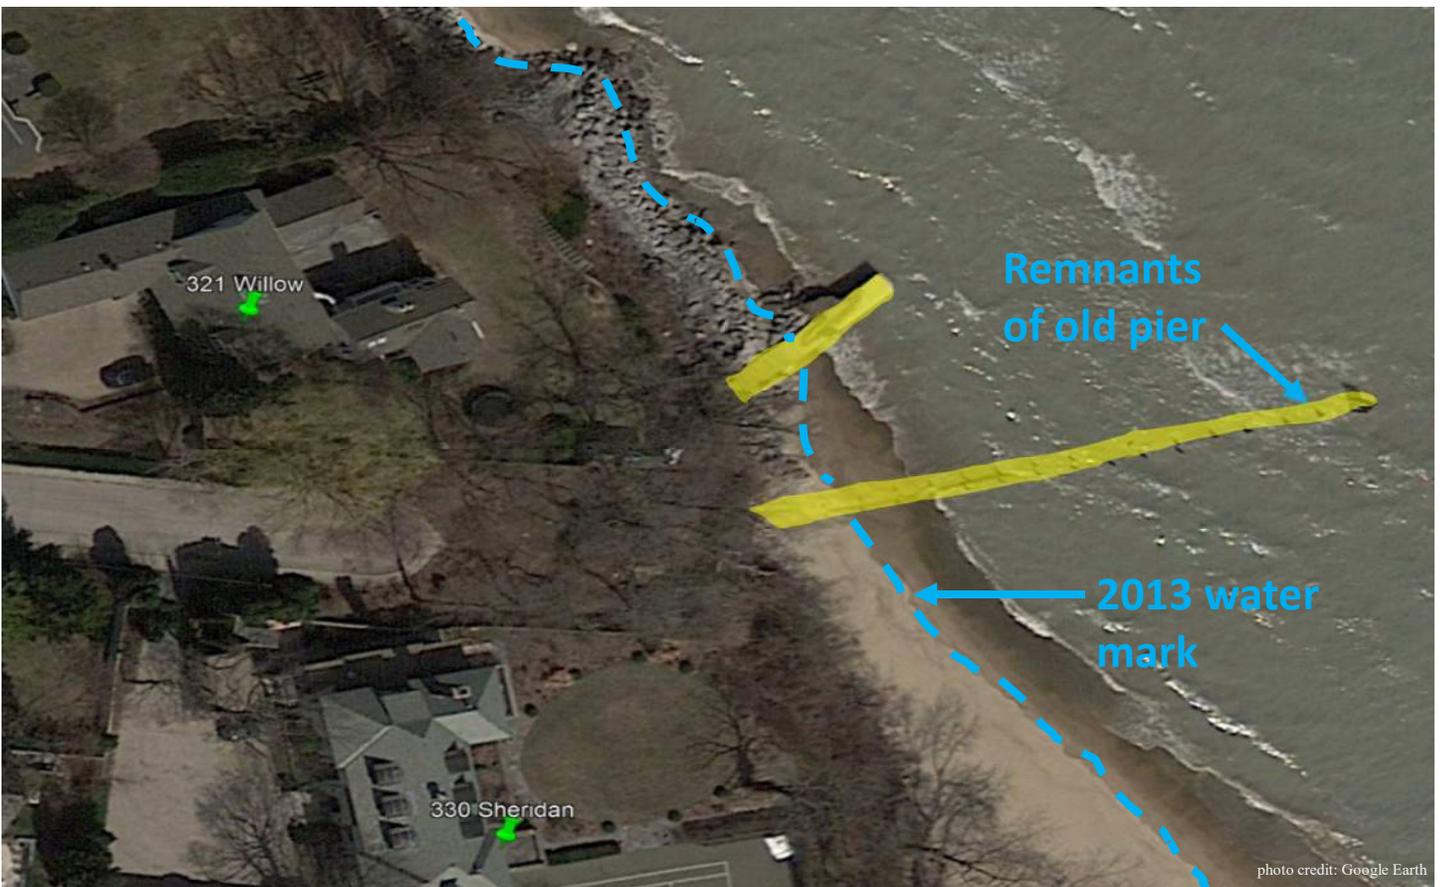
### 321 Willow Road

The top of this damaged private pier is approximately 24” above the beach grade at the water line. This structure blocks pedestrian movement along the shoreline. A pedestrian would need to scale this structure in order to safely walk the beach below the OHWM. Even when the lake level was low in 2013, the pier blocked pedestrian movement along the shoreline. In addition, there are scattered remnants of an old pier which are only visible during low lake levels – these are dangerous under foot.

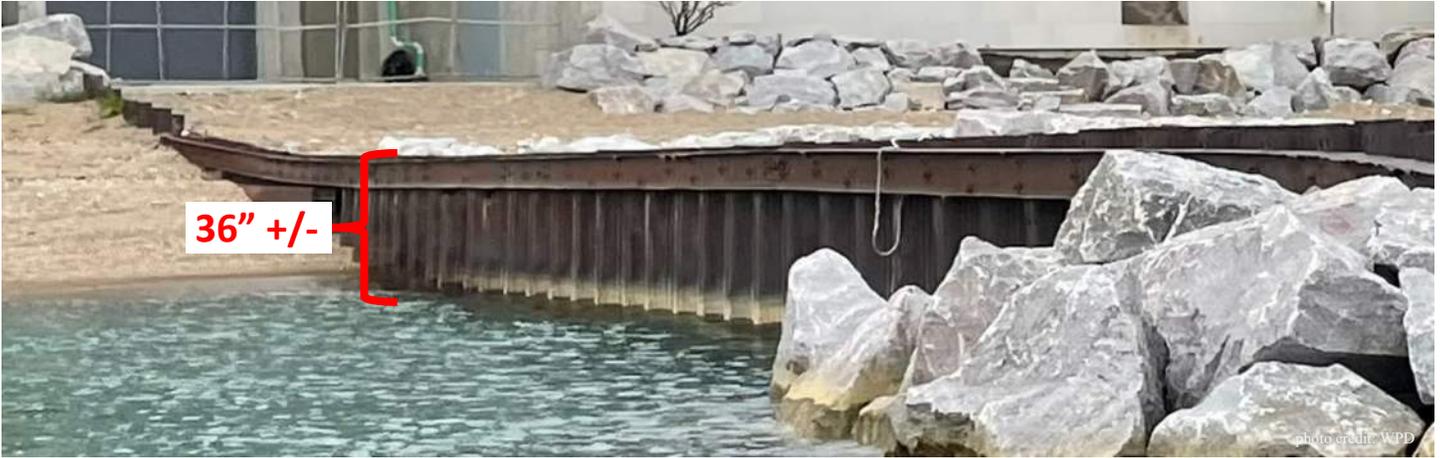
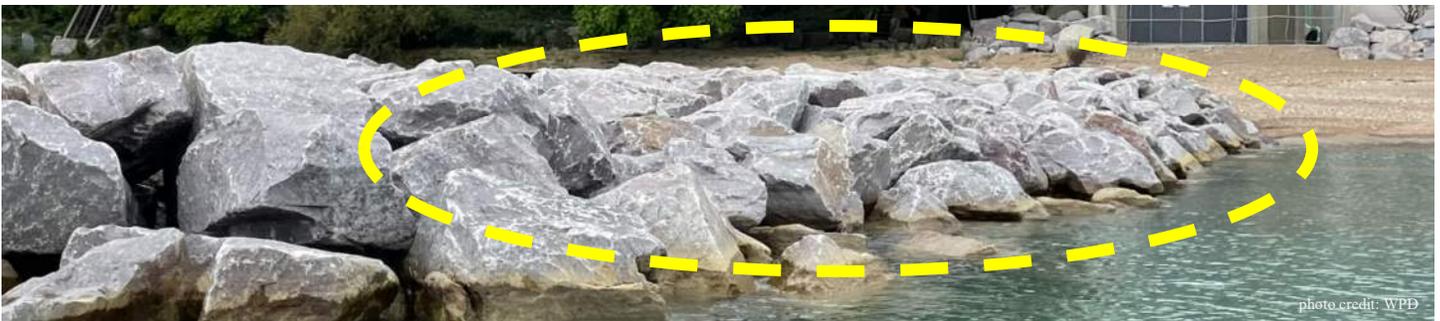
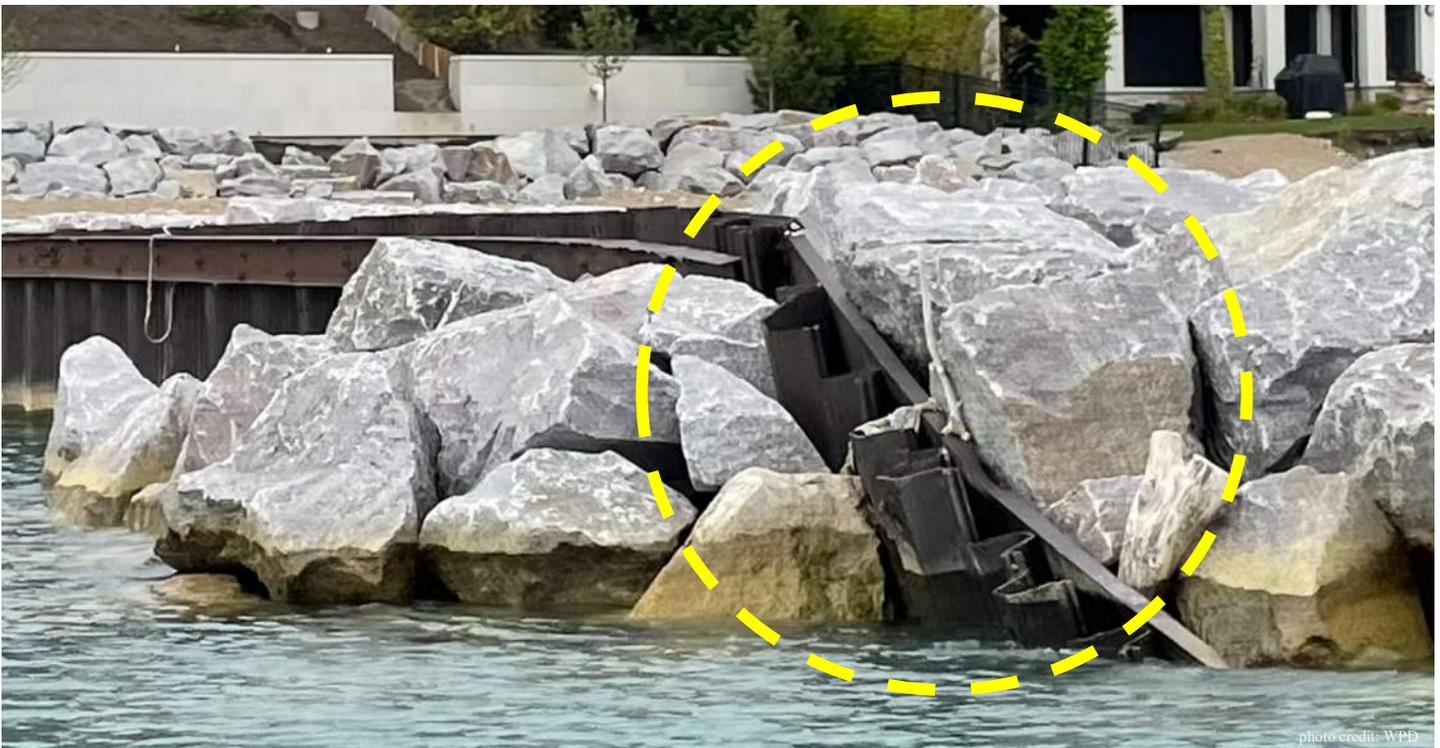
### 515 to 519 Sheridan

The top of the groin is approximately 36" above the waterline on the south face. This structure blocks pedestrian movement along the shoreline. A pedestrian would need to scale this unsafe structure in order to safely walk the beach below the OHWM. Additionally, there are stones on the north side of the groin, making climbing up and over even more treacherous. The steel groin is damaged and has been displaced by the stone revetment.
