Winnetka Park District

Elder and Centennial  
Park and Beach Project Presentation

October 13, 2021

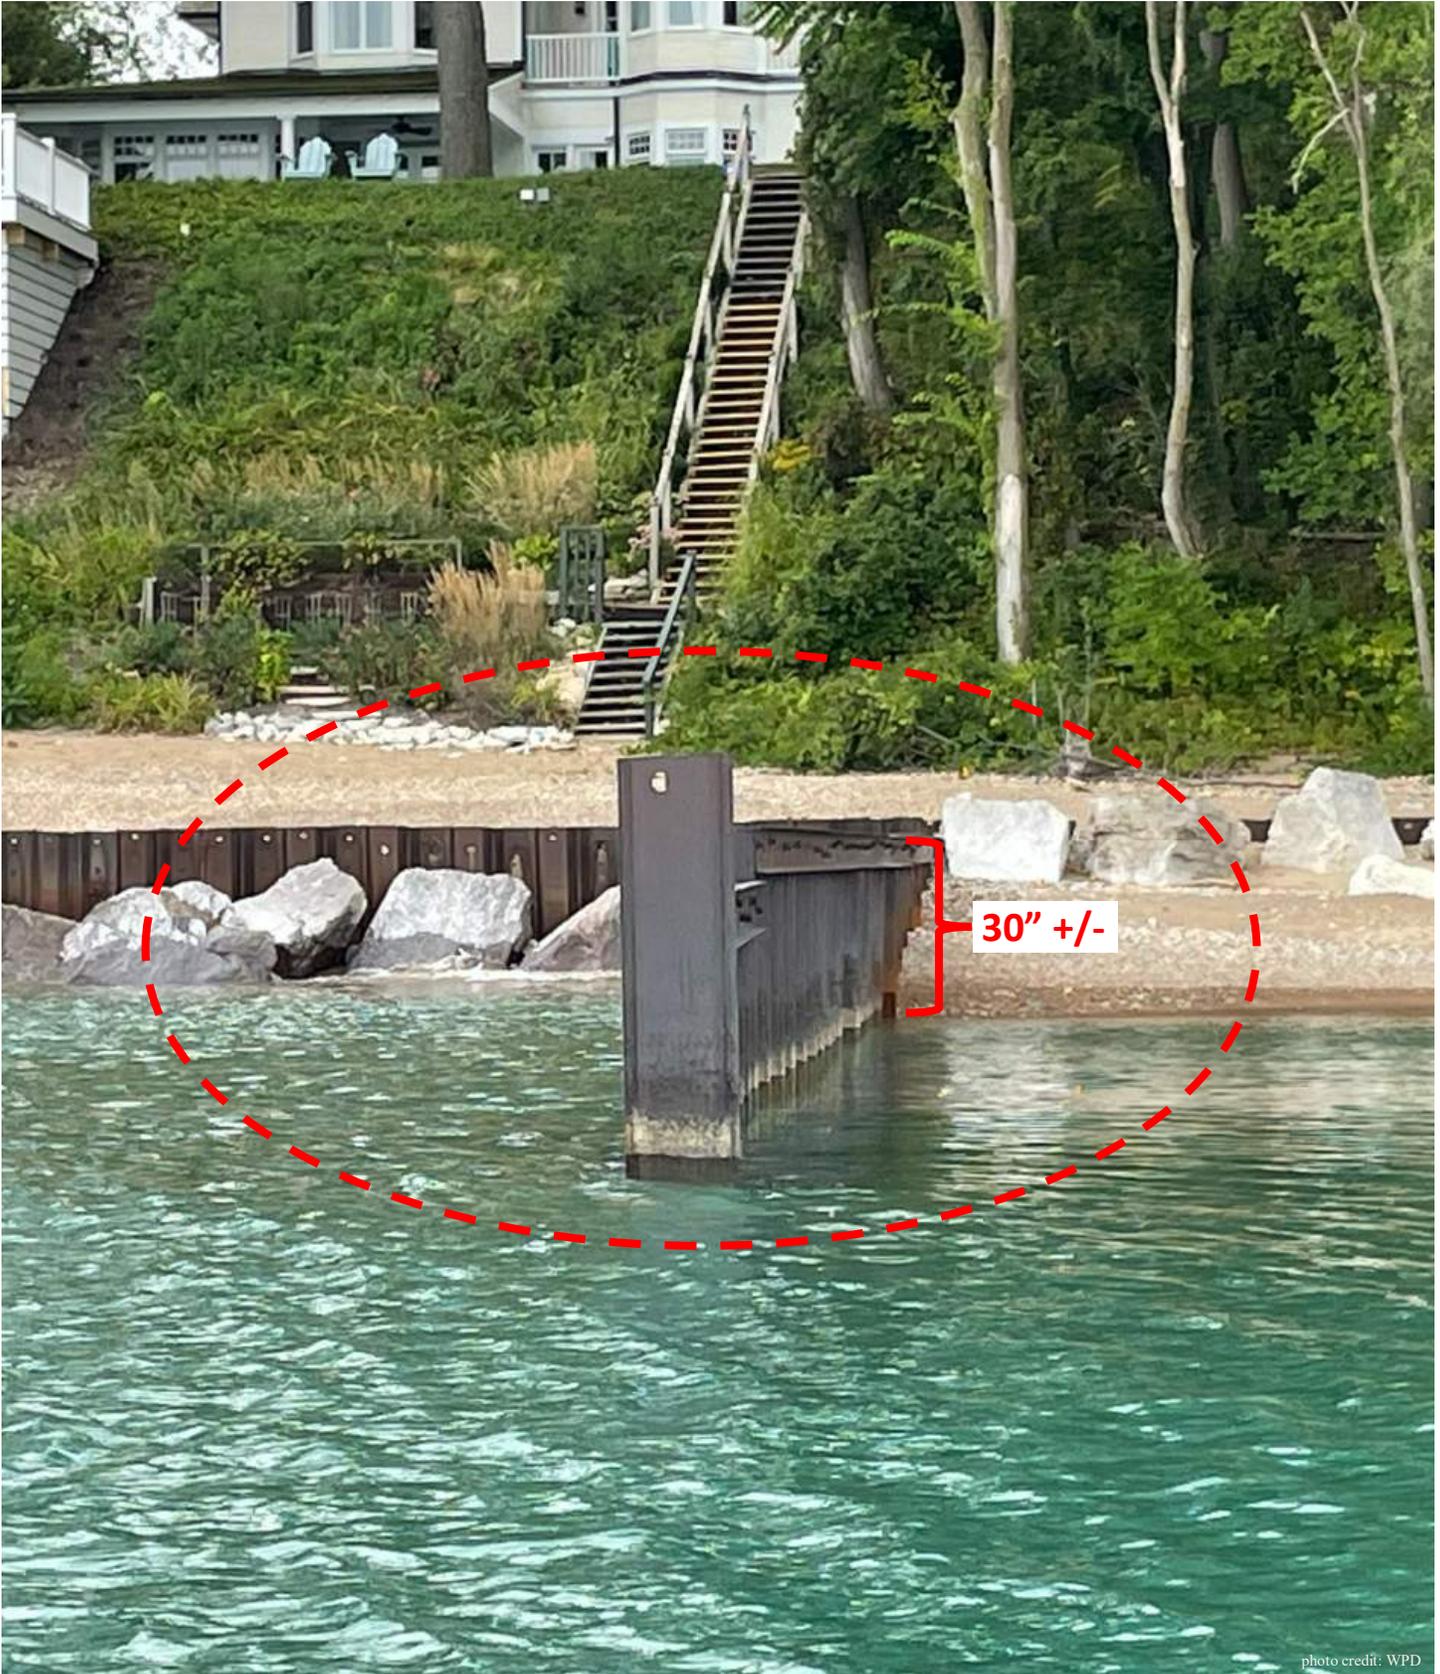
### 525 Elm to 555 Sheridan

The top of the groin is approximately 30" above the water line on the north face. This structure blocks pedestrian movement along the shoreline. A pedestrian would need to scale this unsafe structure in order to safely walk the beach below the OHWM.

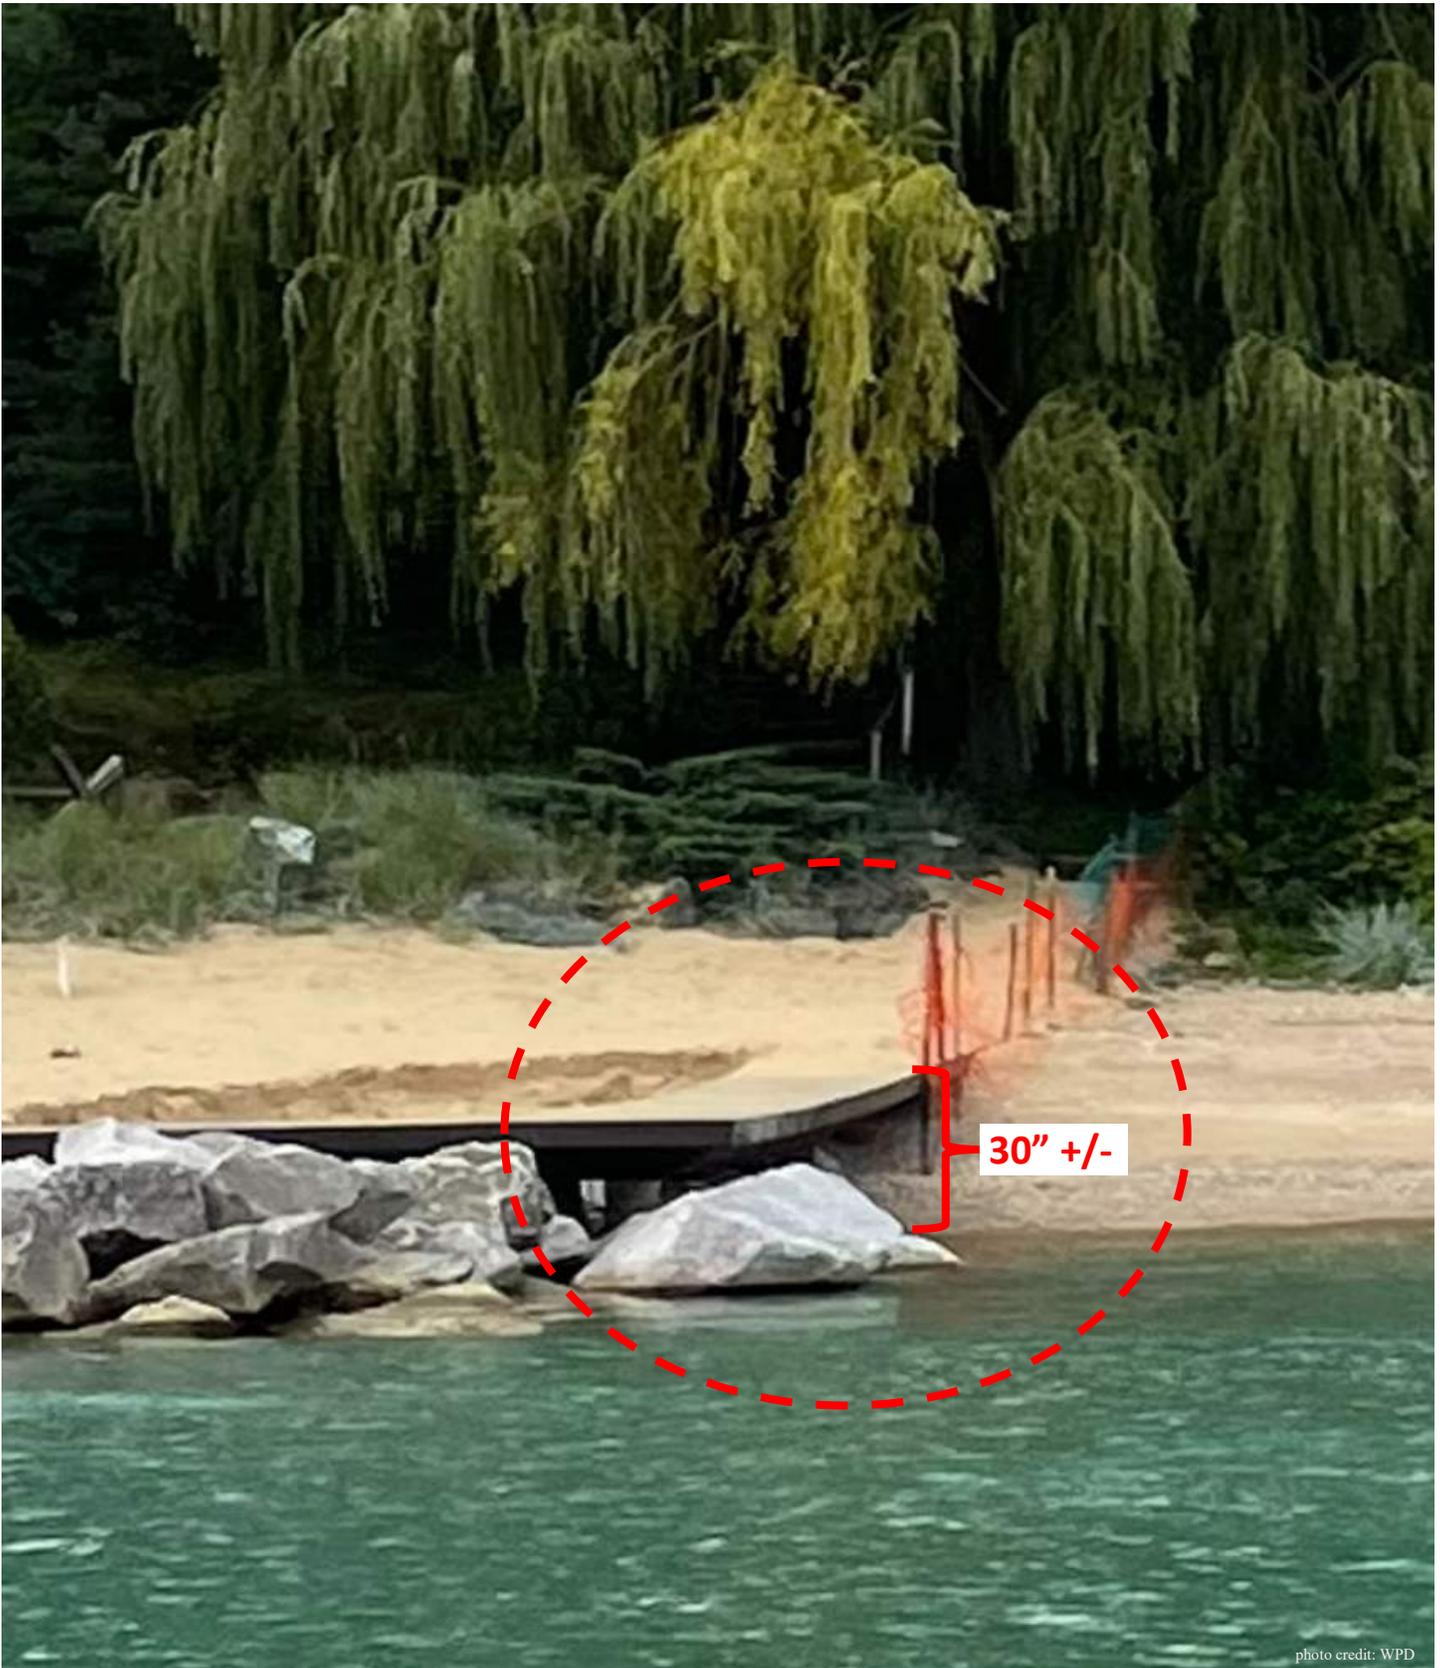
### 667 Sheridan

The top of this pier is approximately 30" above the water line on the north face. This structure, in addition to the fence, blocks pedestrian movement along the shoreline. Furthermore, this structure presents a fall risk for any pedestrian who should attempt to move along the shoreline from north to south.
