## Elder Lane + Centennial Beach Project Timeline

# Elder + Centennial | Phase One

ELDER | CENTENNIAL  
BEACH FEASIBILITY STUDY

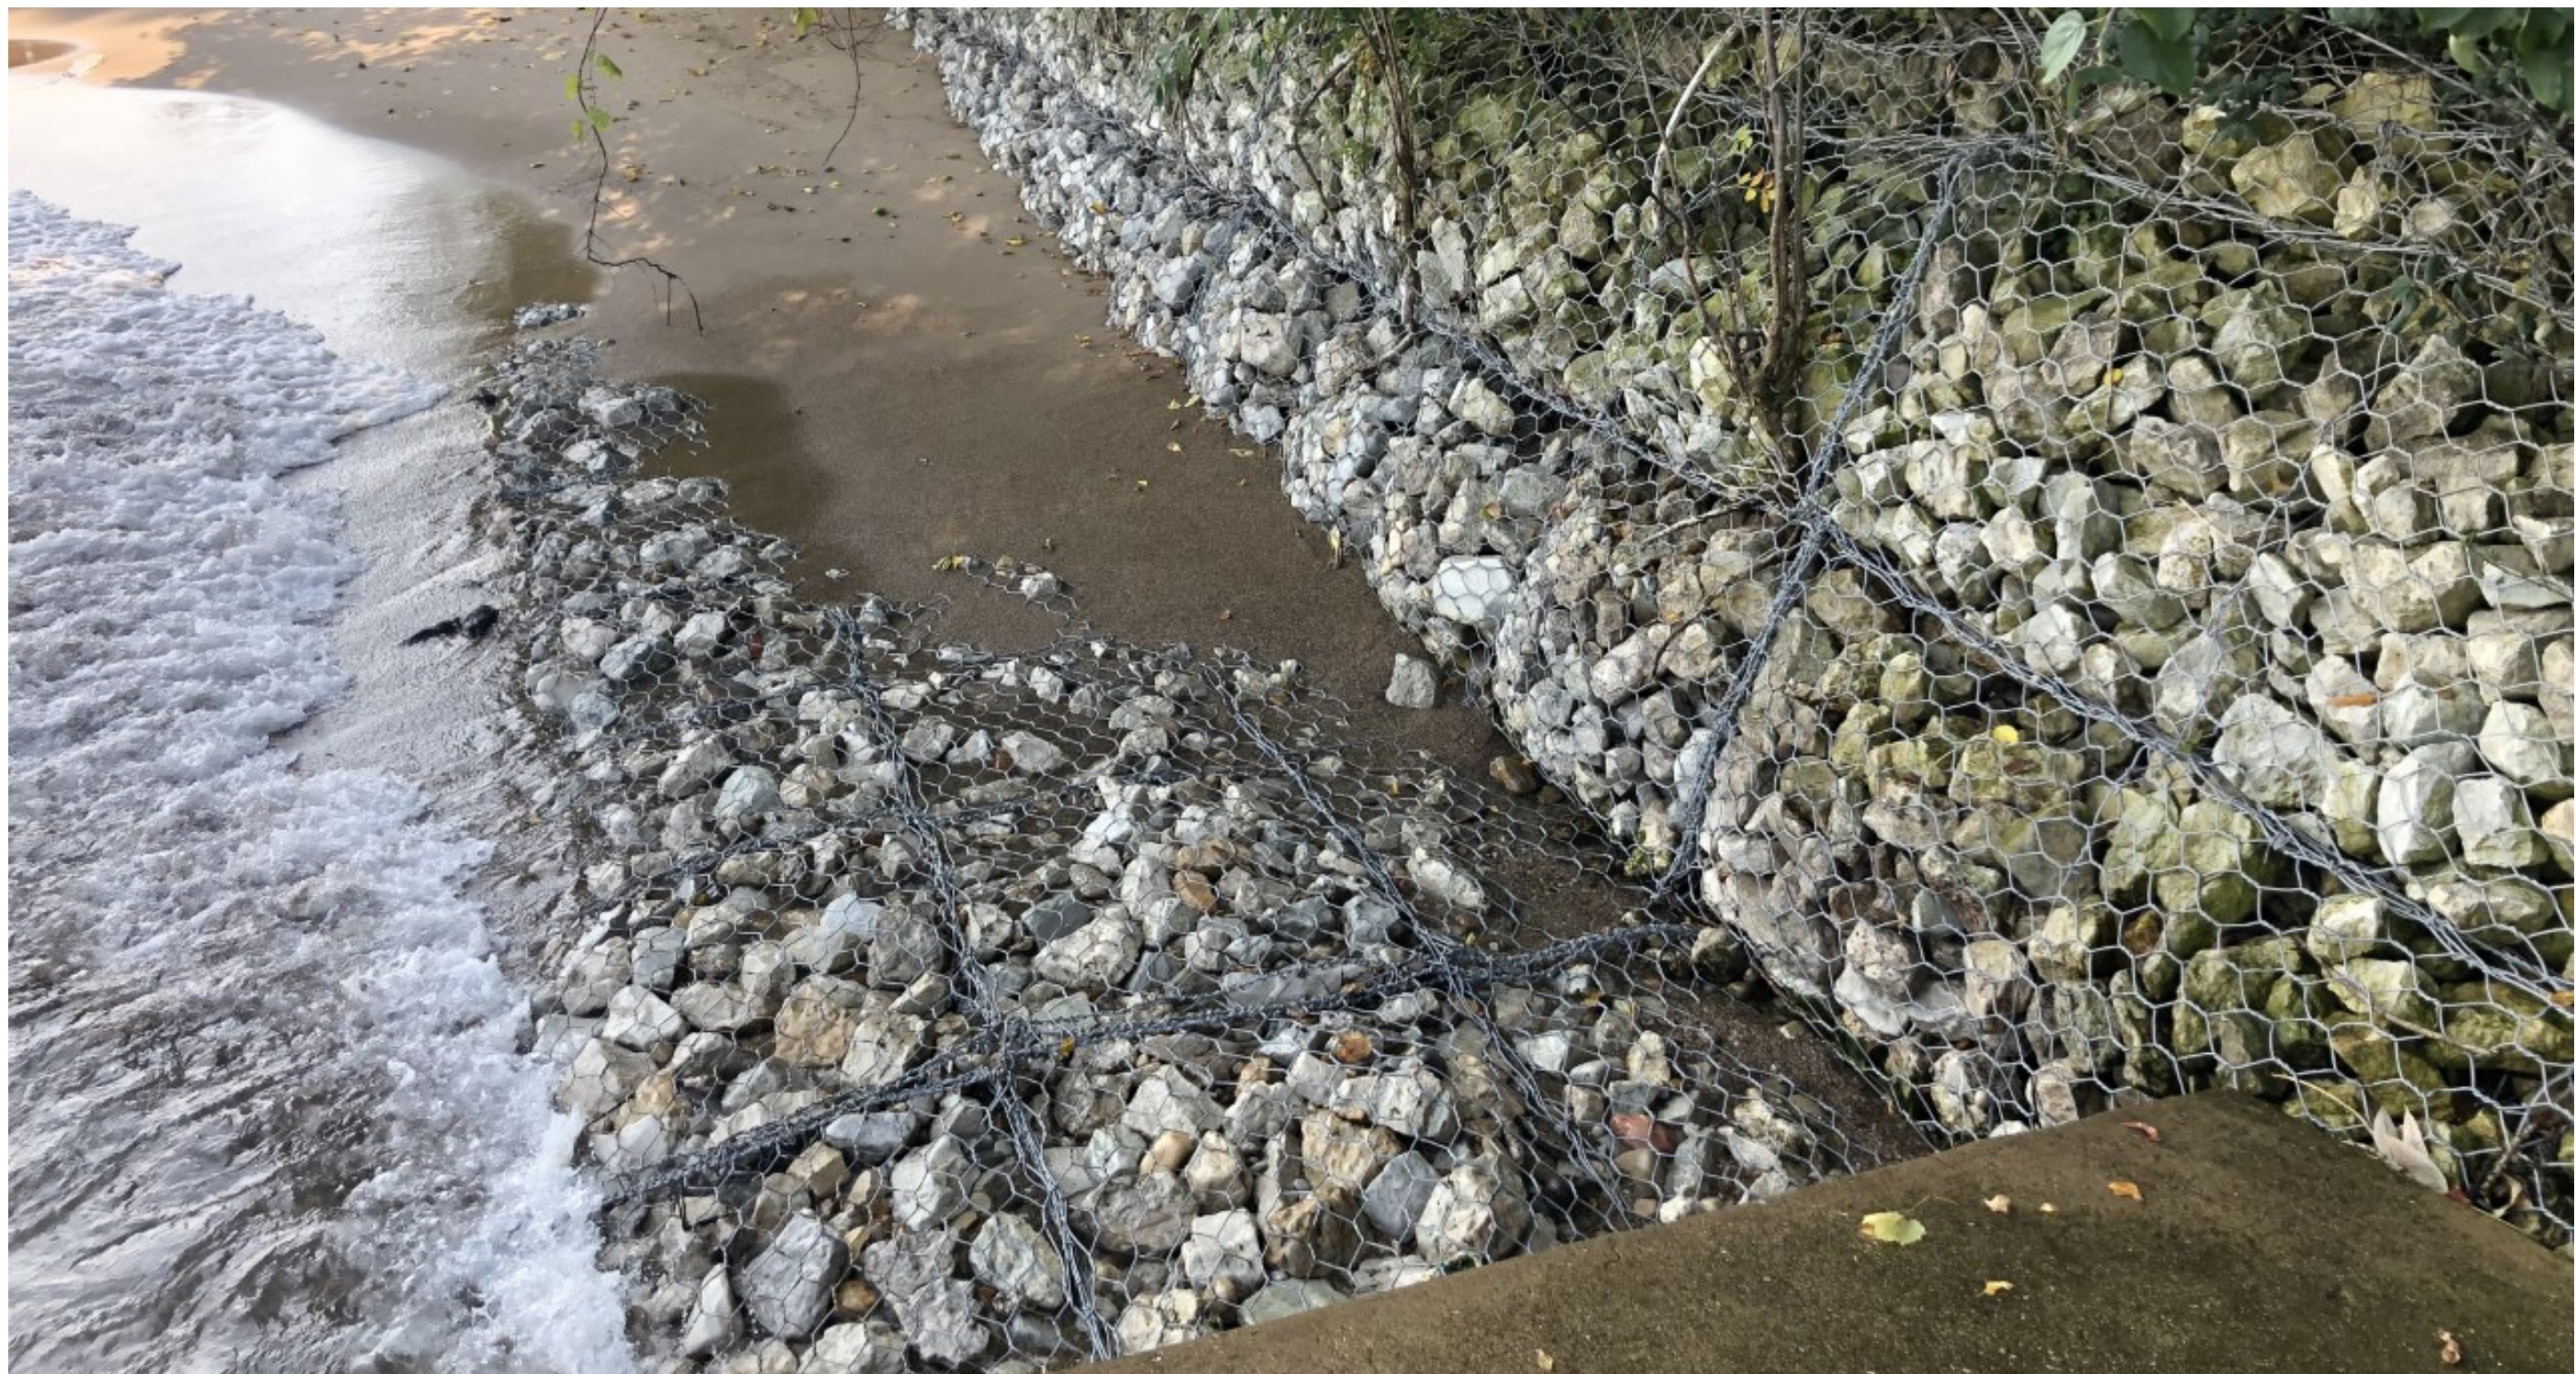
ELDER LANE | FAILING GABION  
BLANKETS OCTOBER 2020

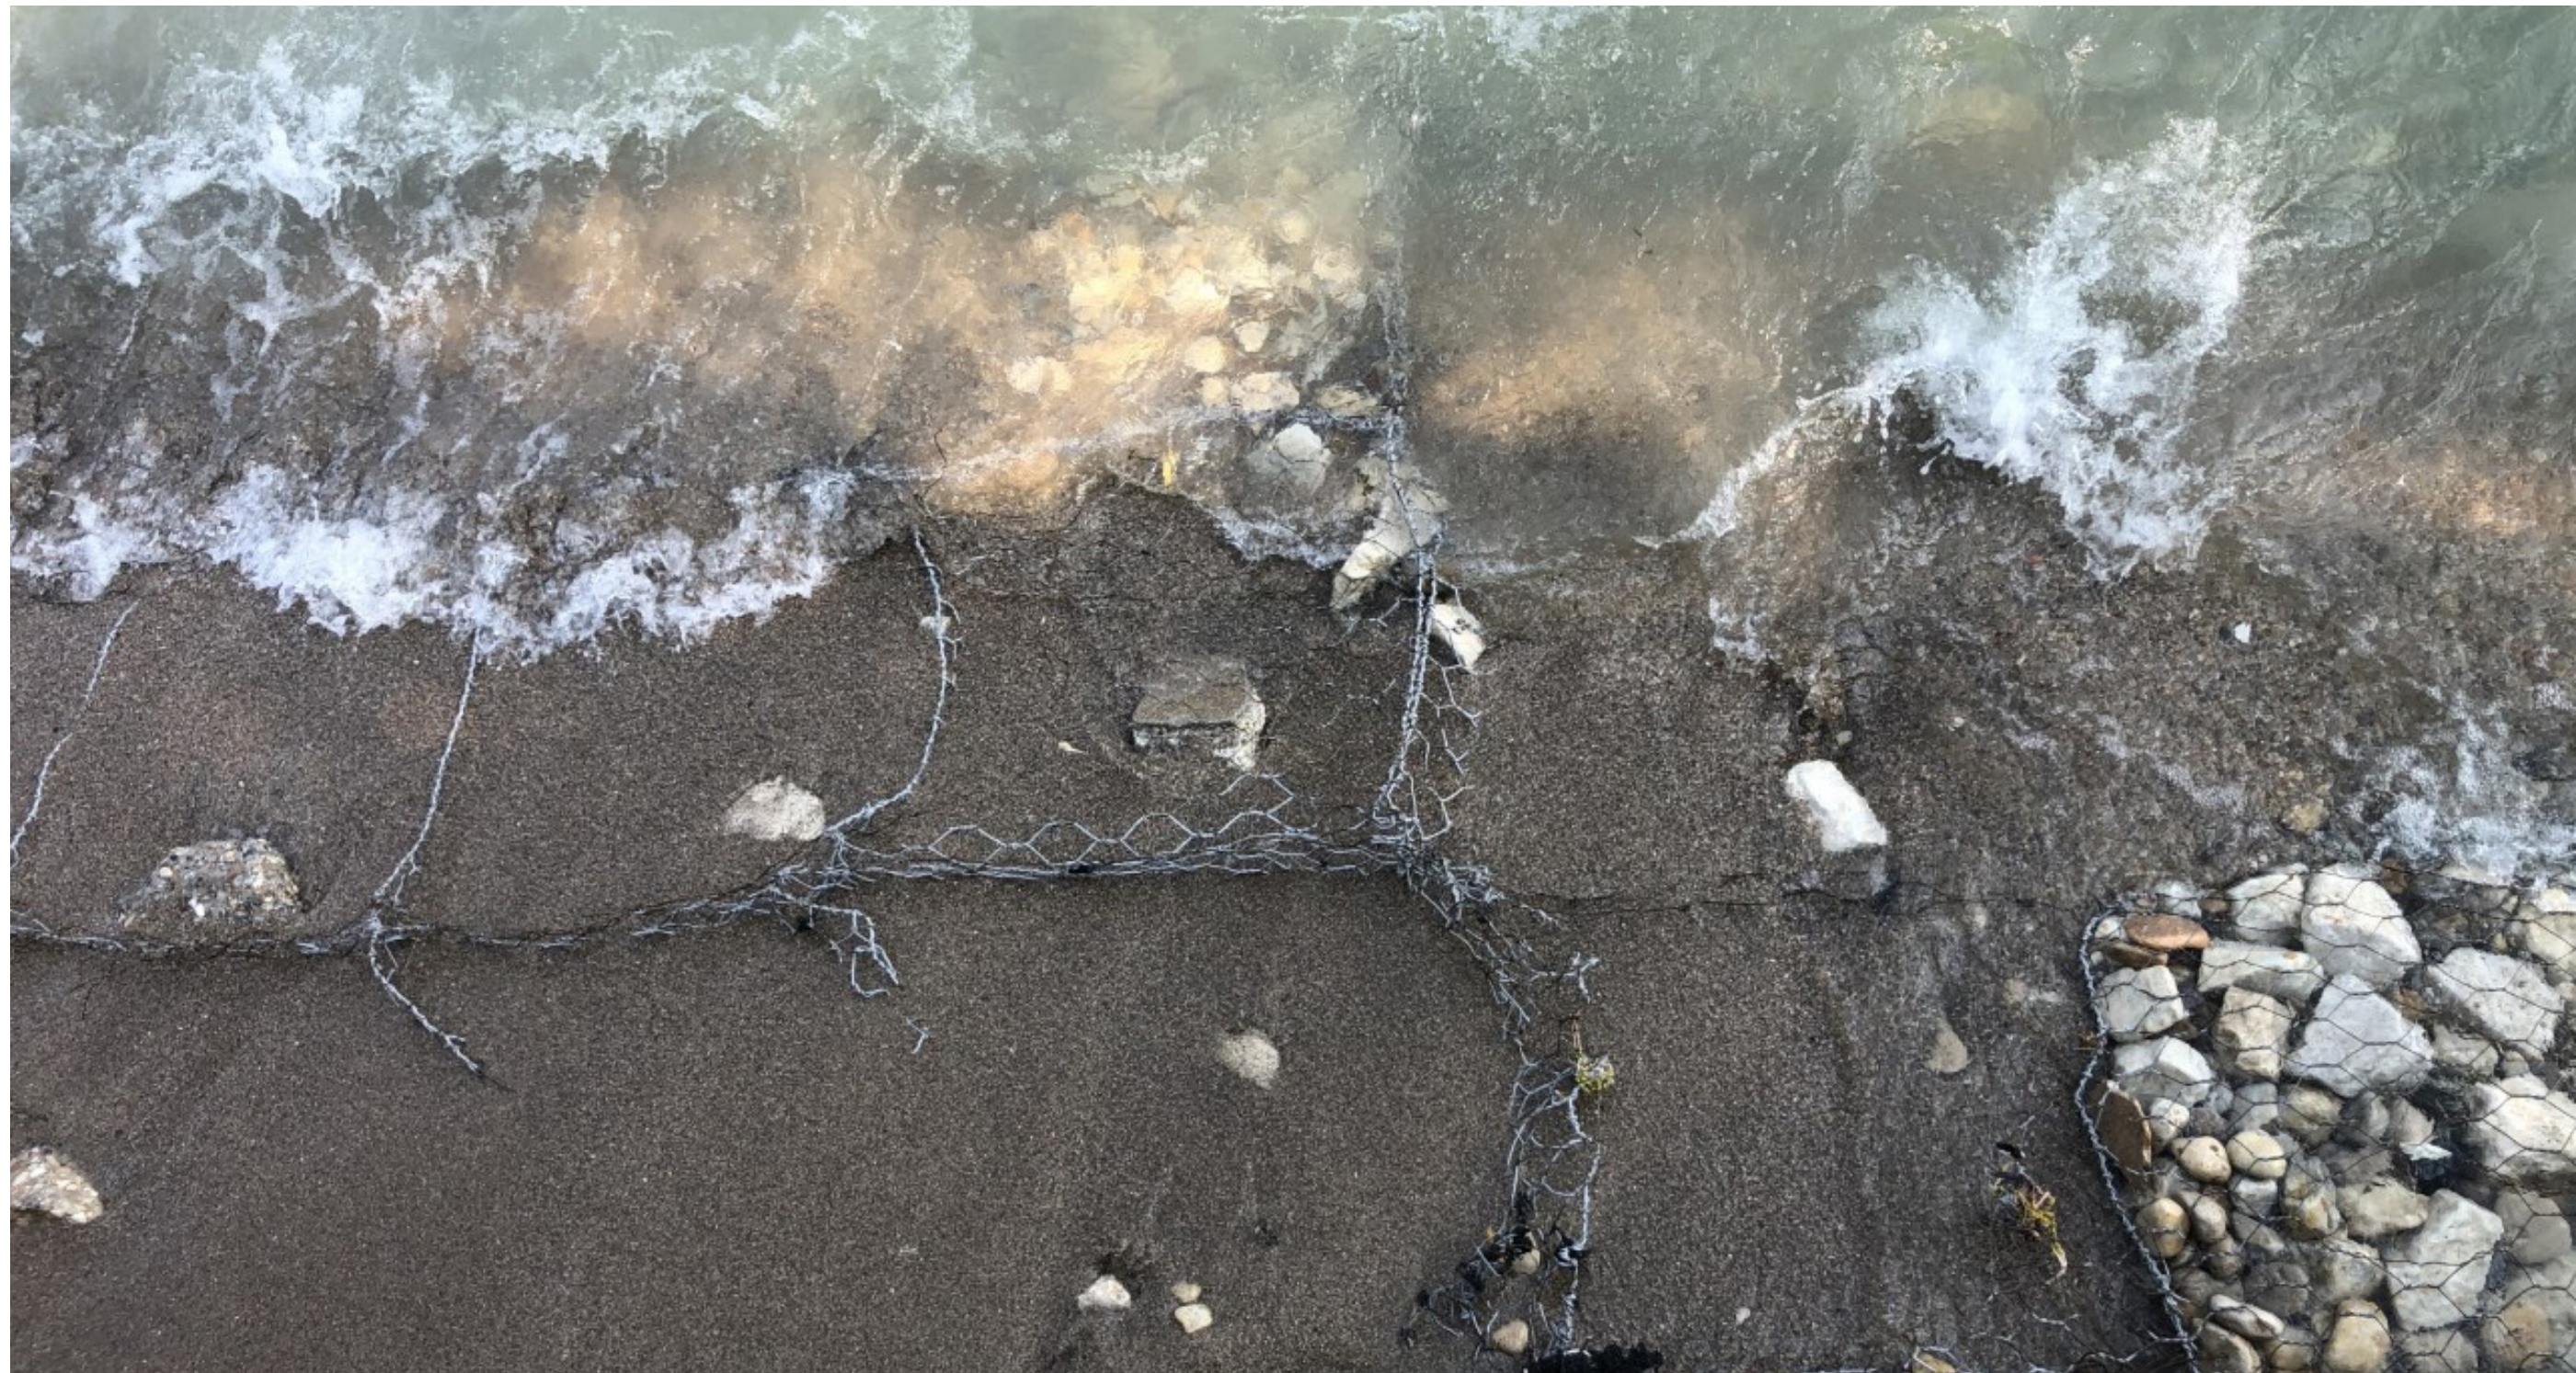
ELDER LANE | FAILING GABION  
BLANKETS OCTOBER 2020

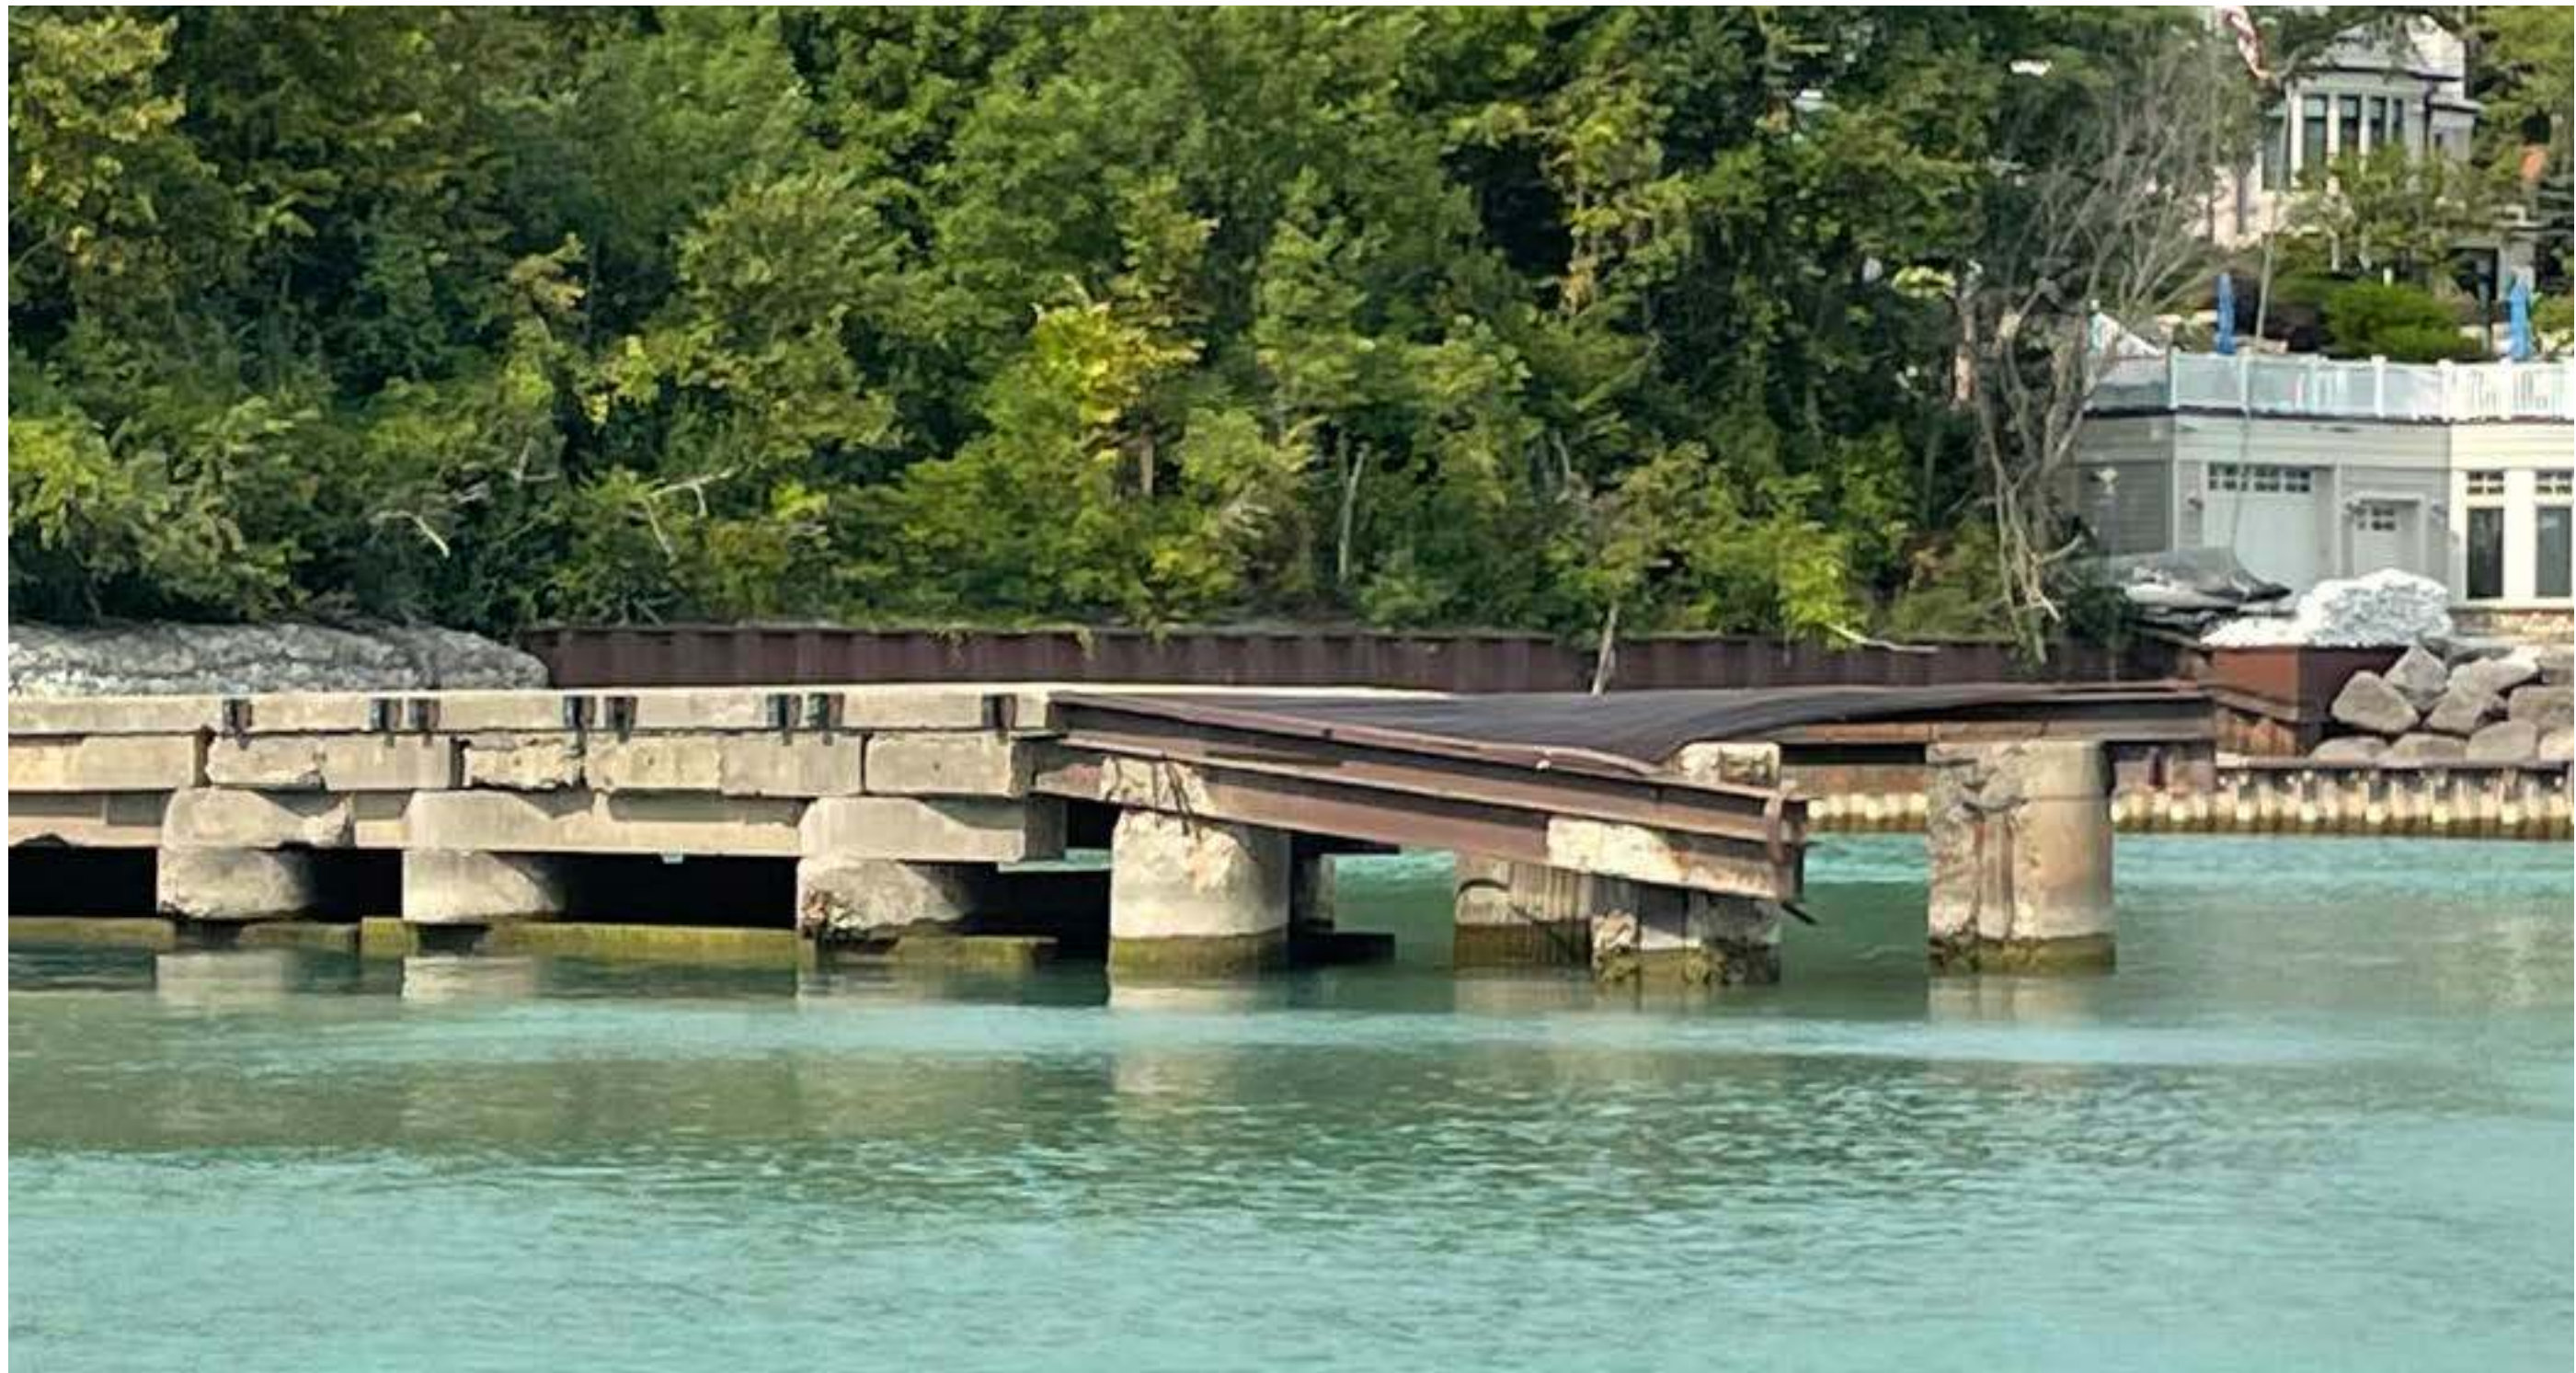
ELDER LANE | FAILING PIER  
SEPTEMBER 2020

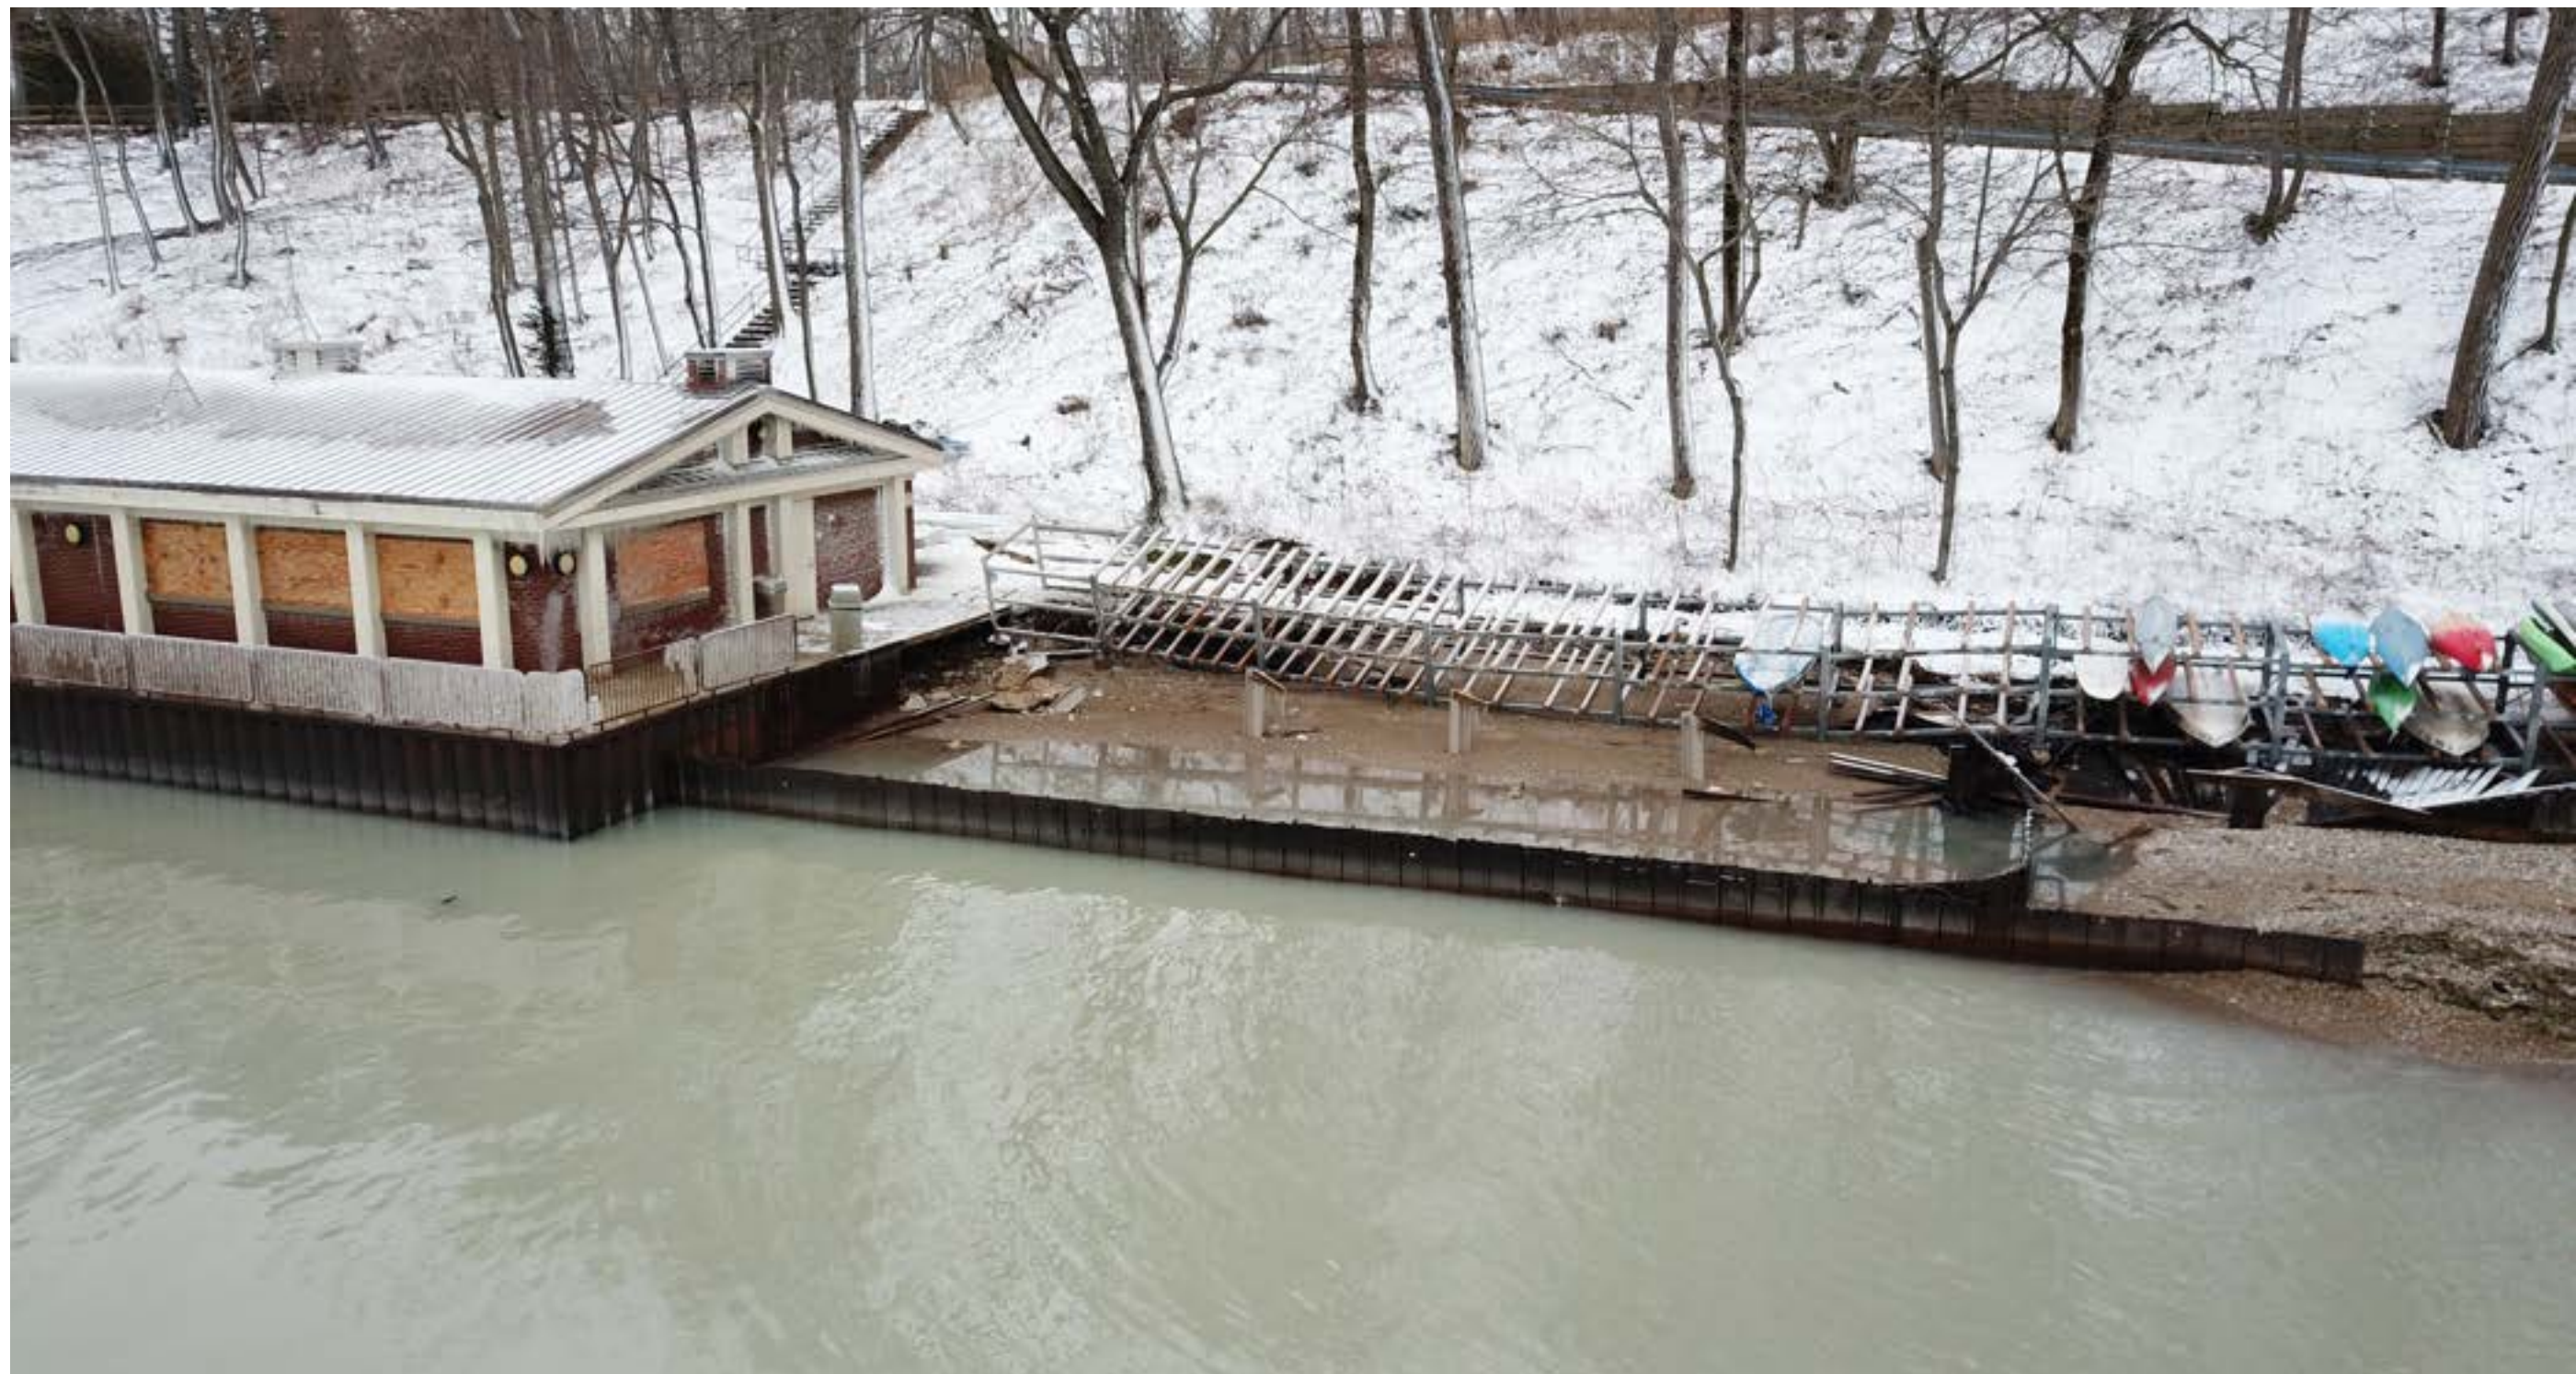
LLOYD | STEEL ELEVATION 584.4  
JANUARY 2020

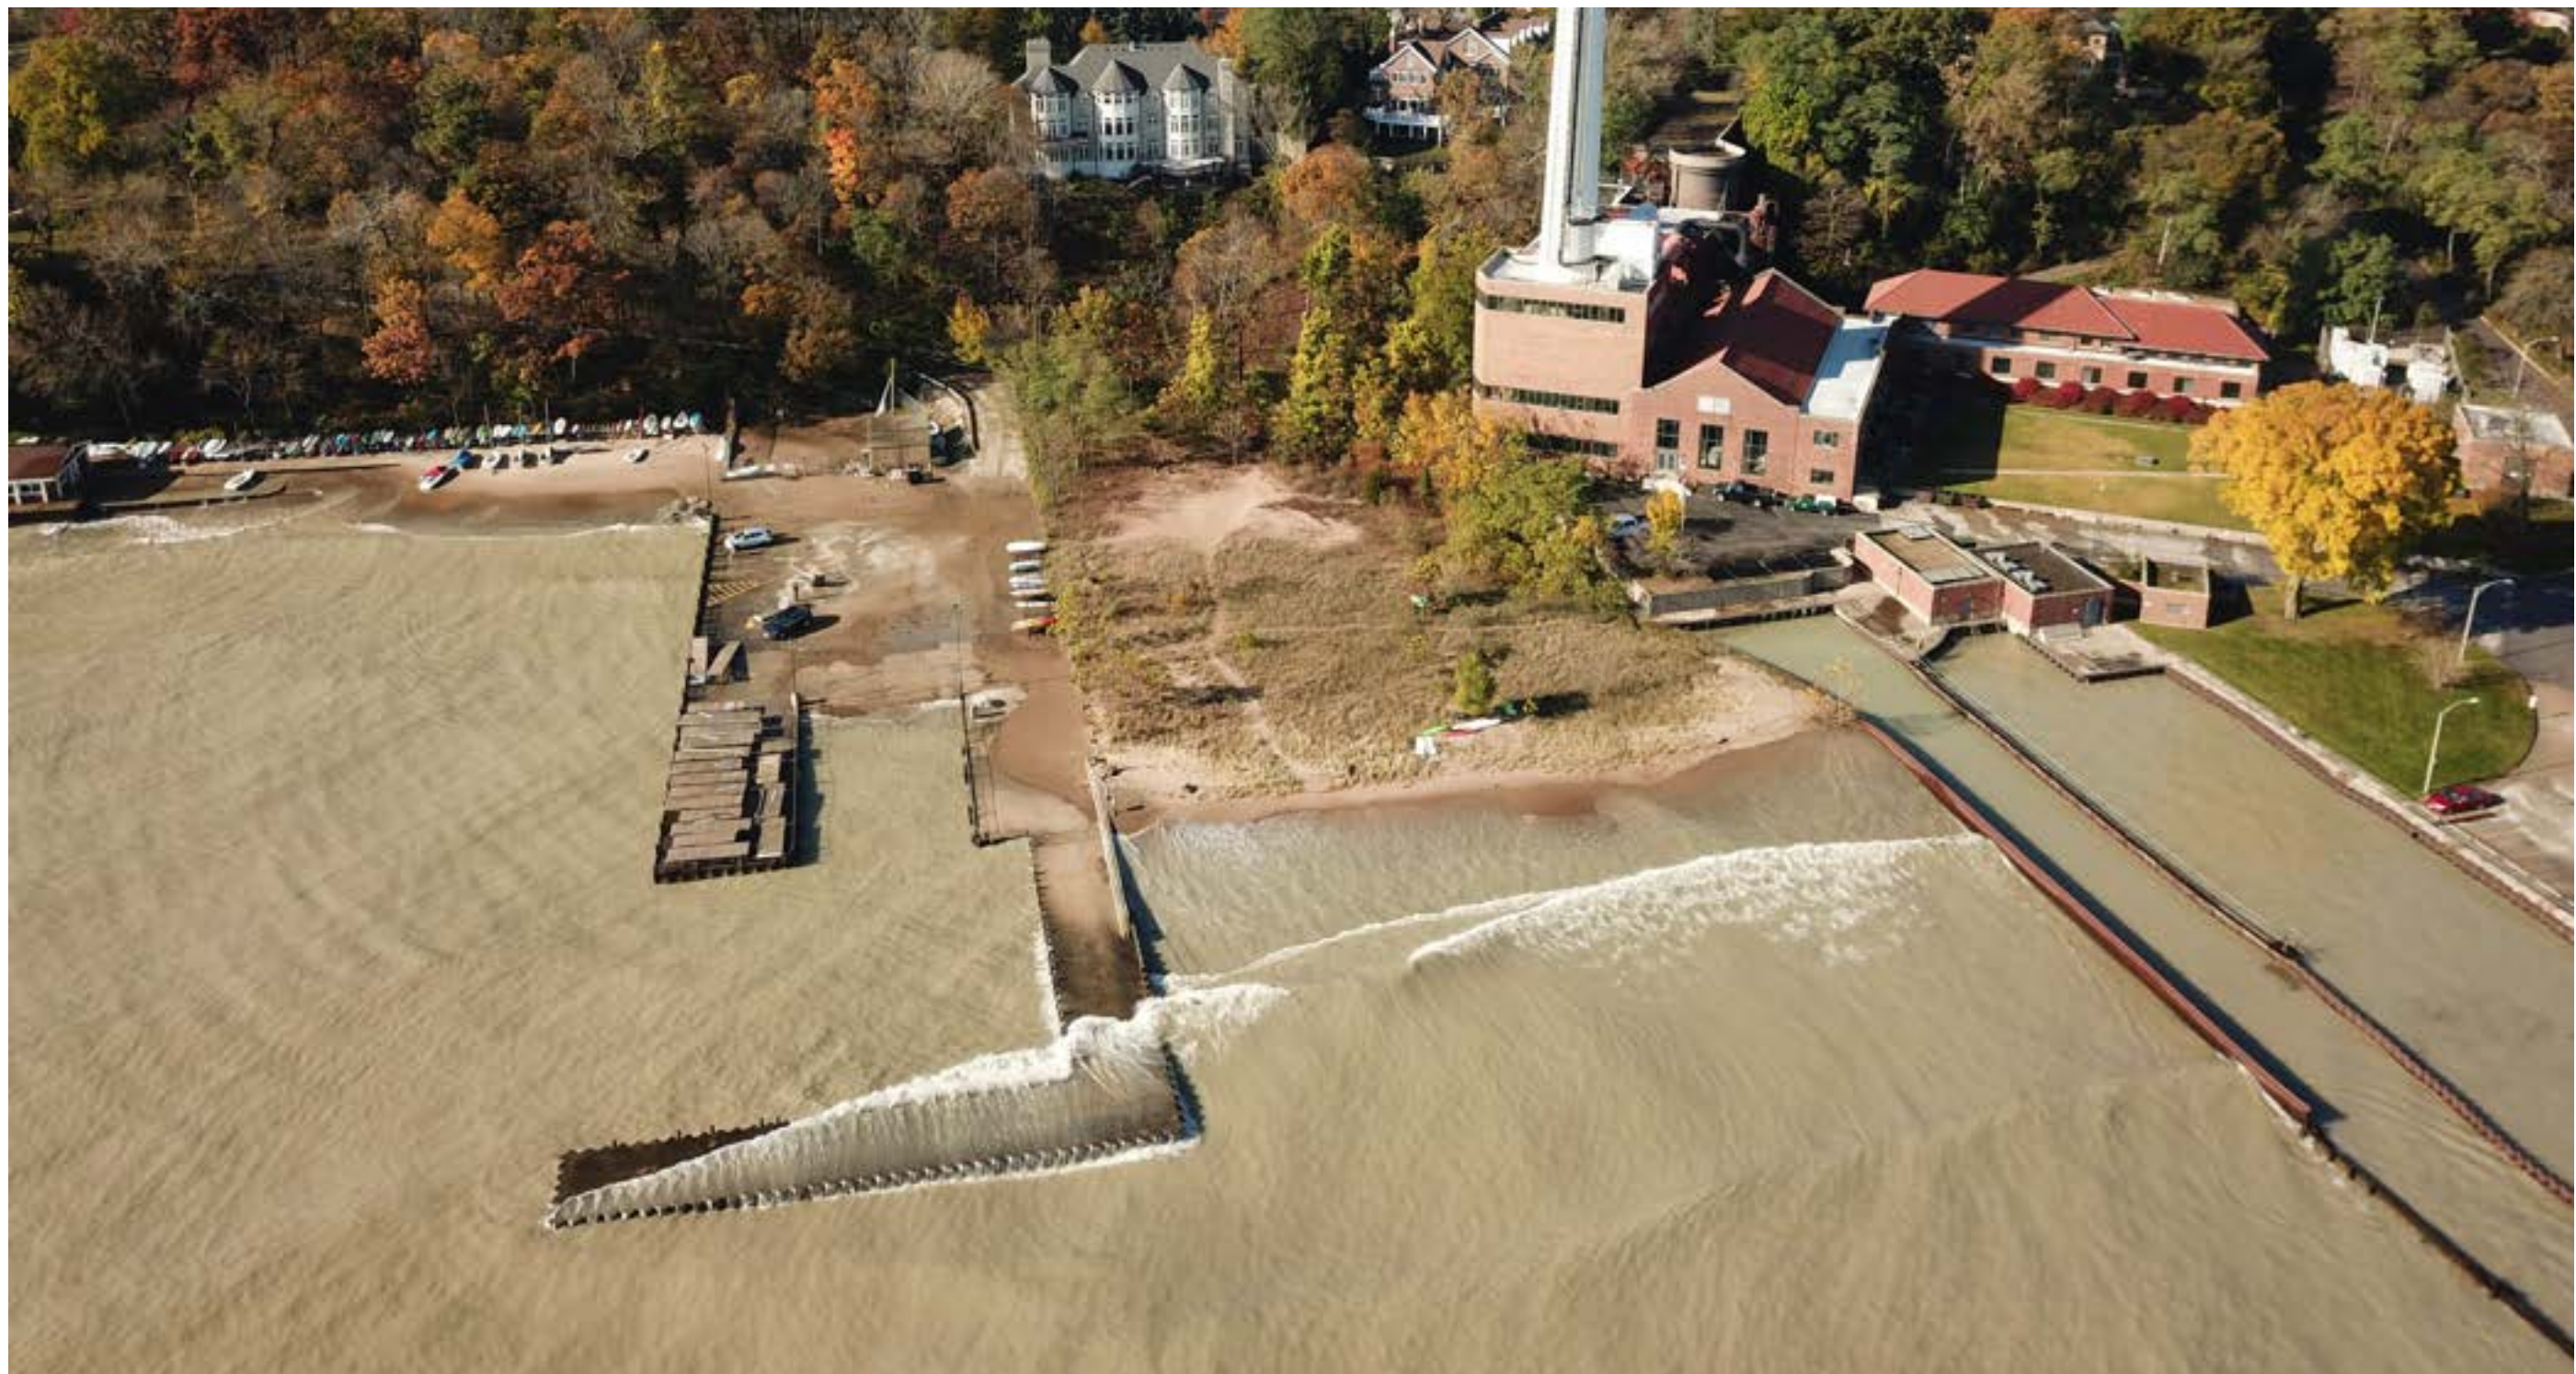
LLOYD | STEEL ELEVATION 583.3  
OCTOBER 2019

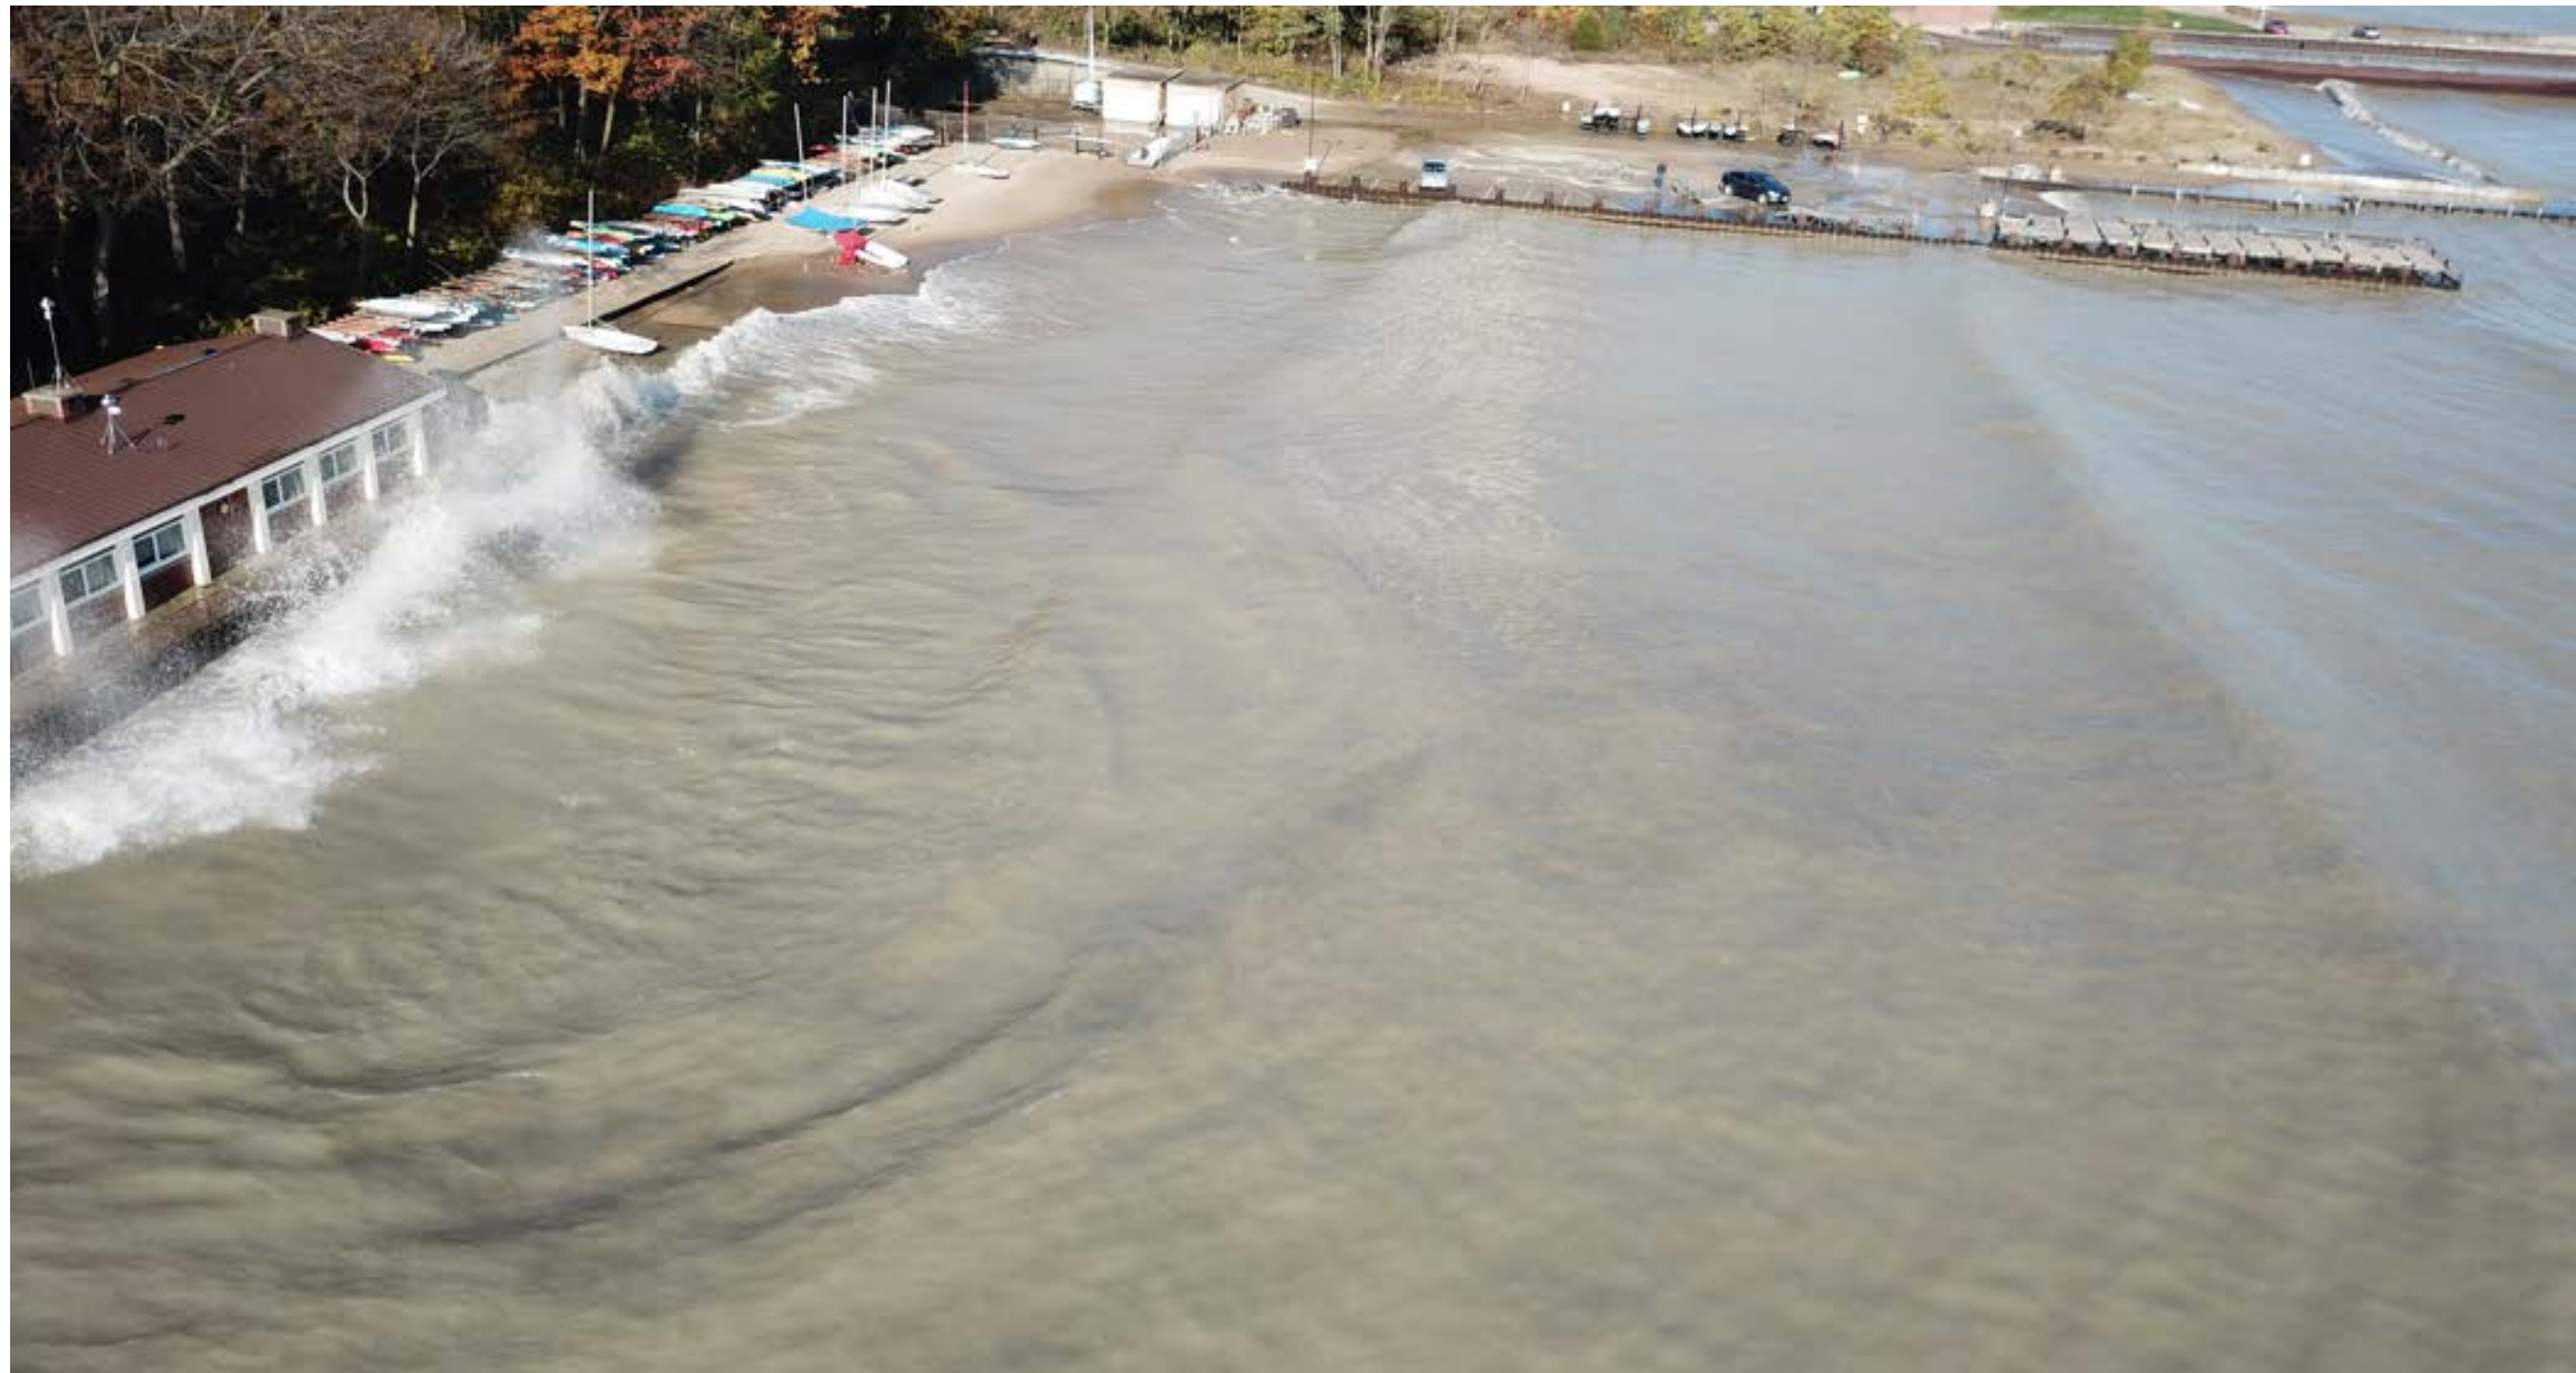
LLOYD | HEIGHT ELEVATION 586.5  
OCTOBER 2019
