## Elder Lane + Centennial Beach Project Timeline

# Elder + Centennial | Phase One

ELDER | CENTENNIAL  
BEACH FEASIBILITY STUDY

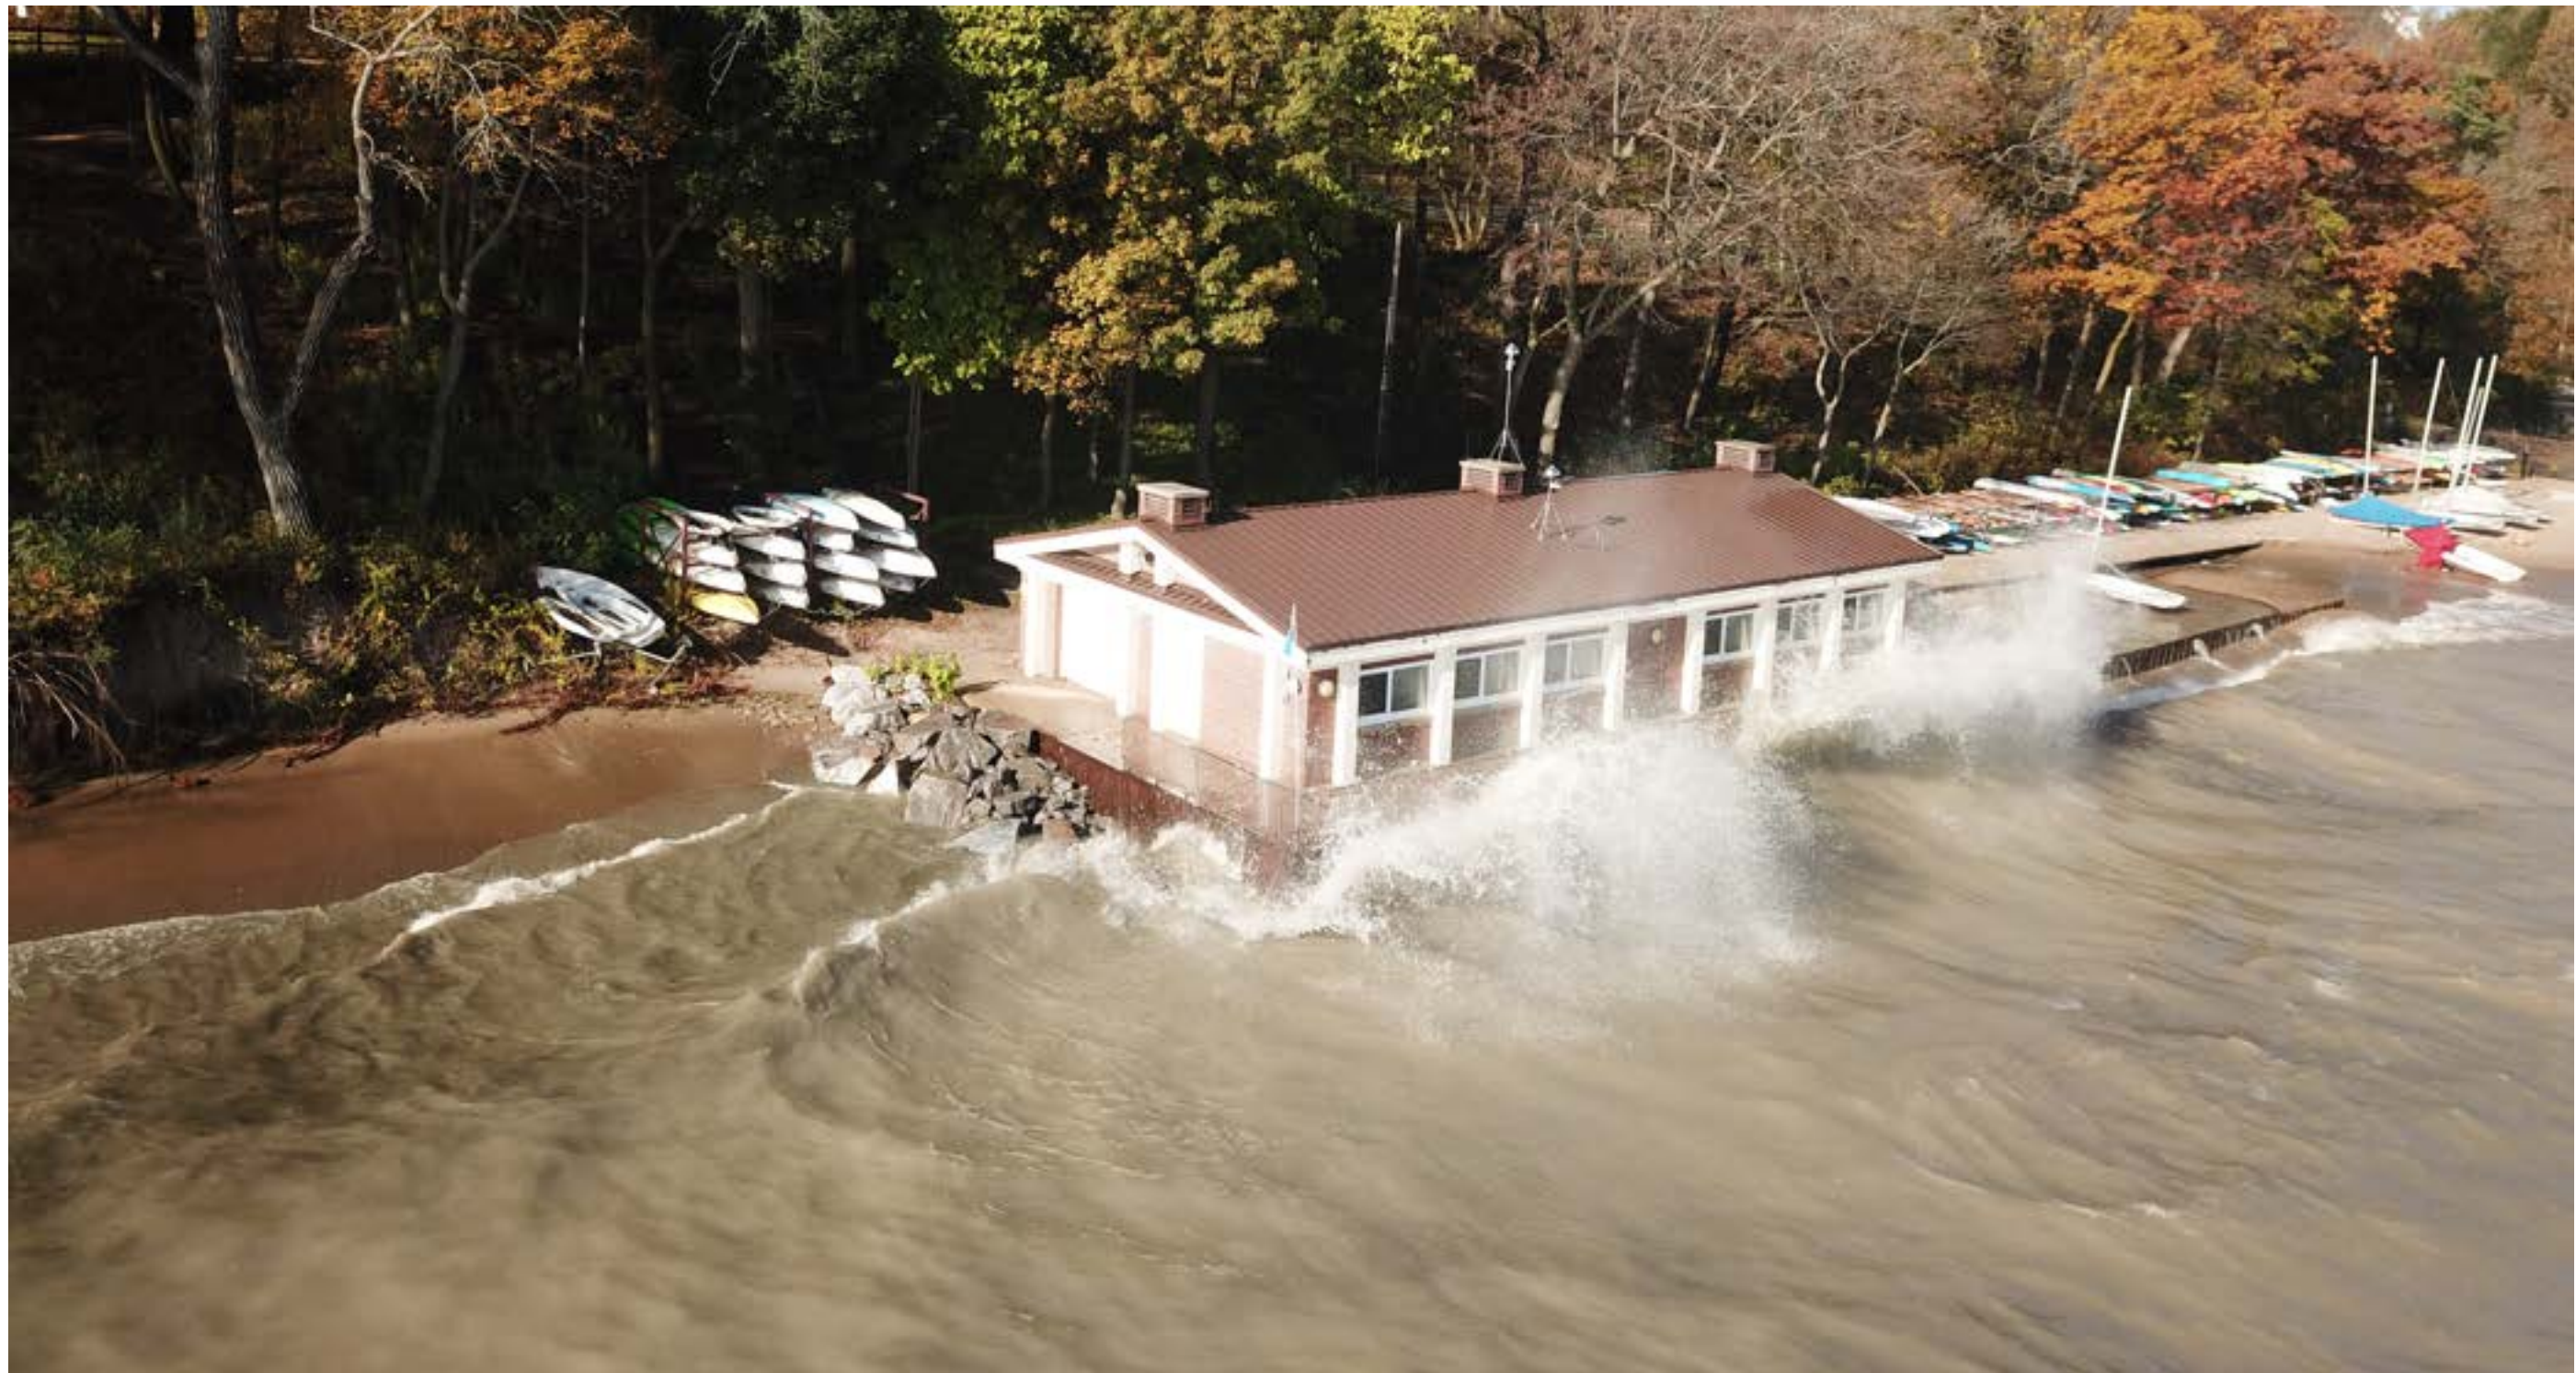
LLOYD | HEIGHT ELEVATION 586.5  
OCTOBER 2019

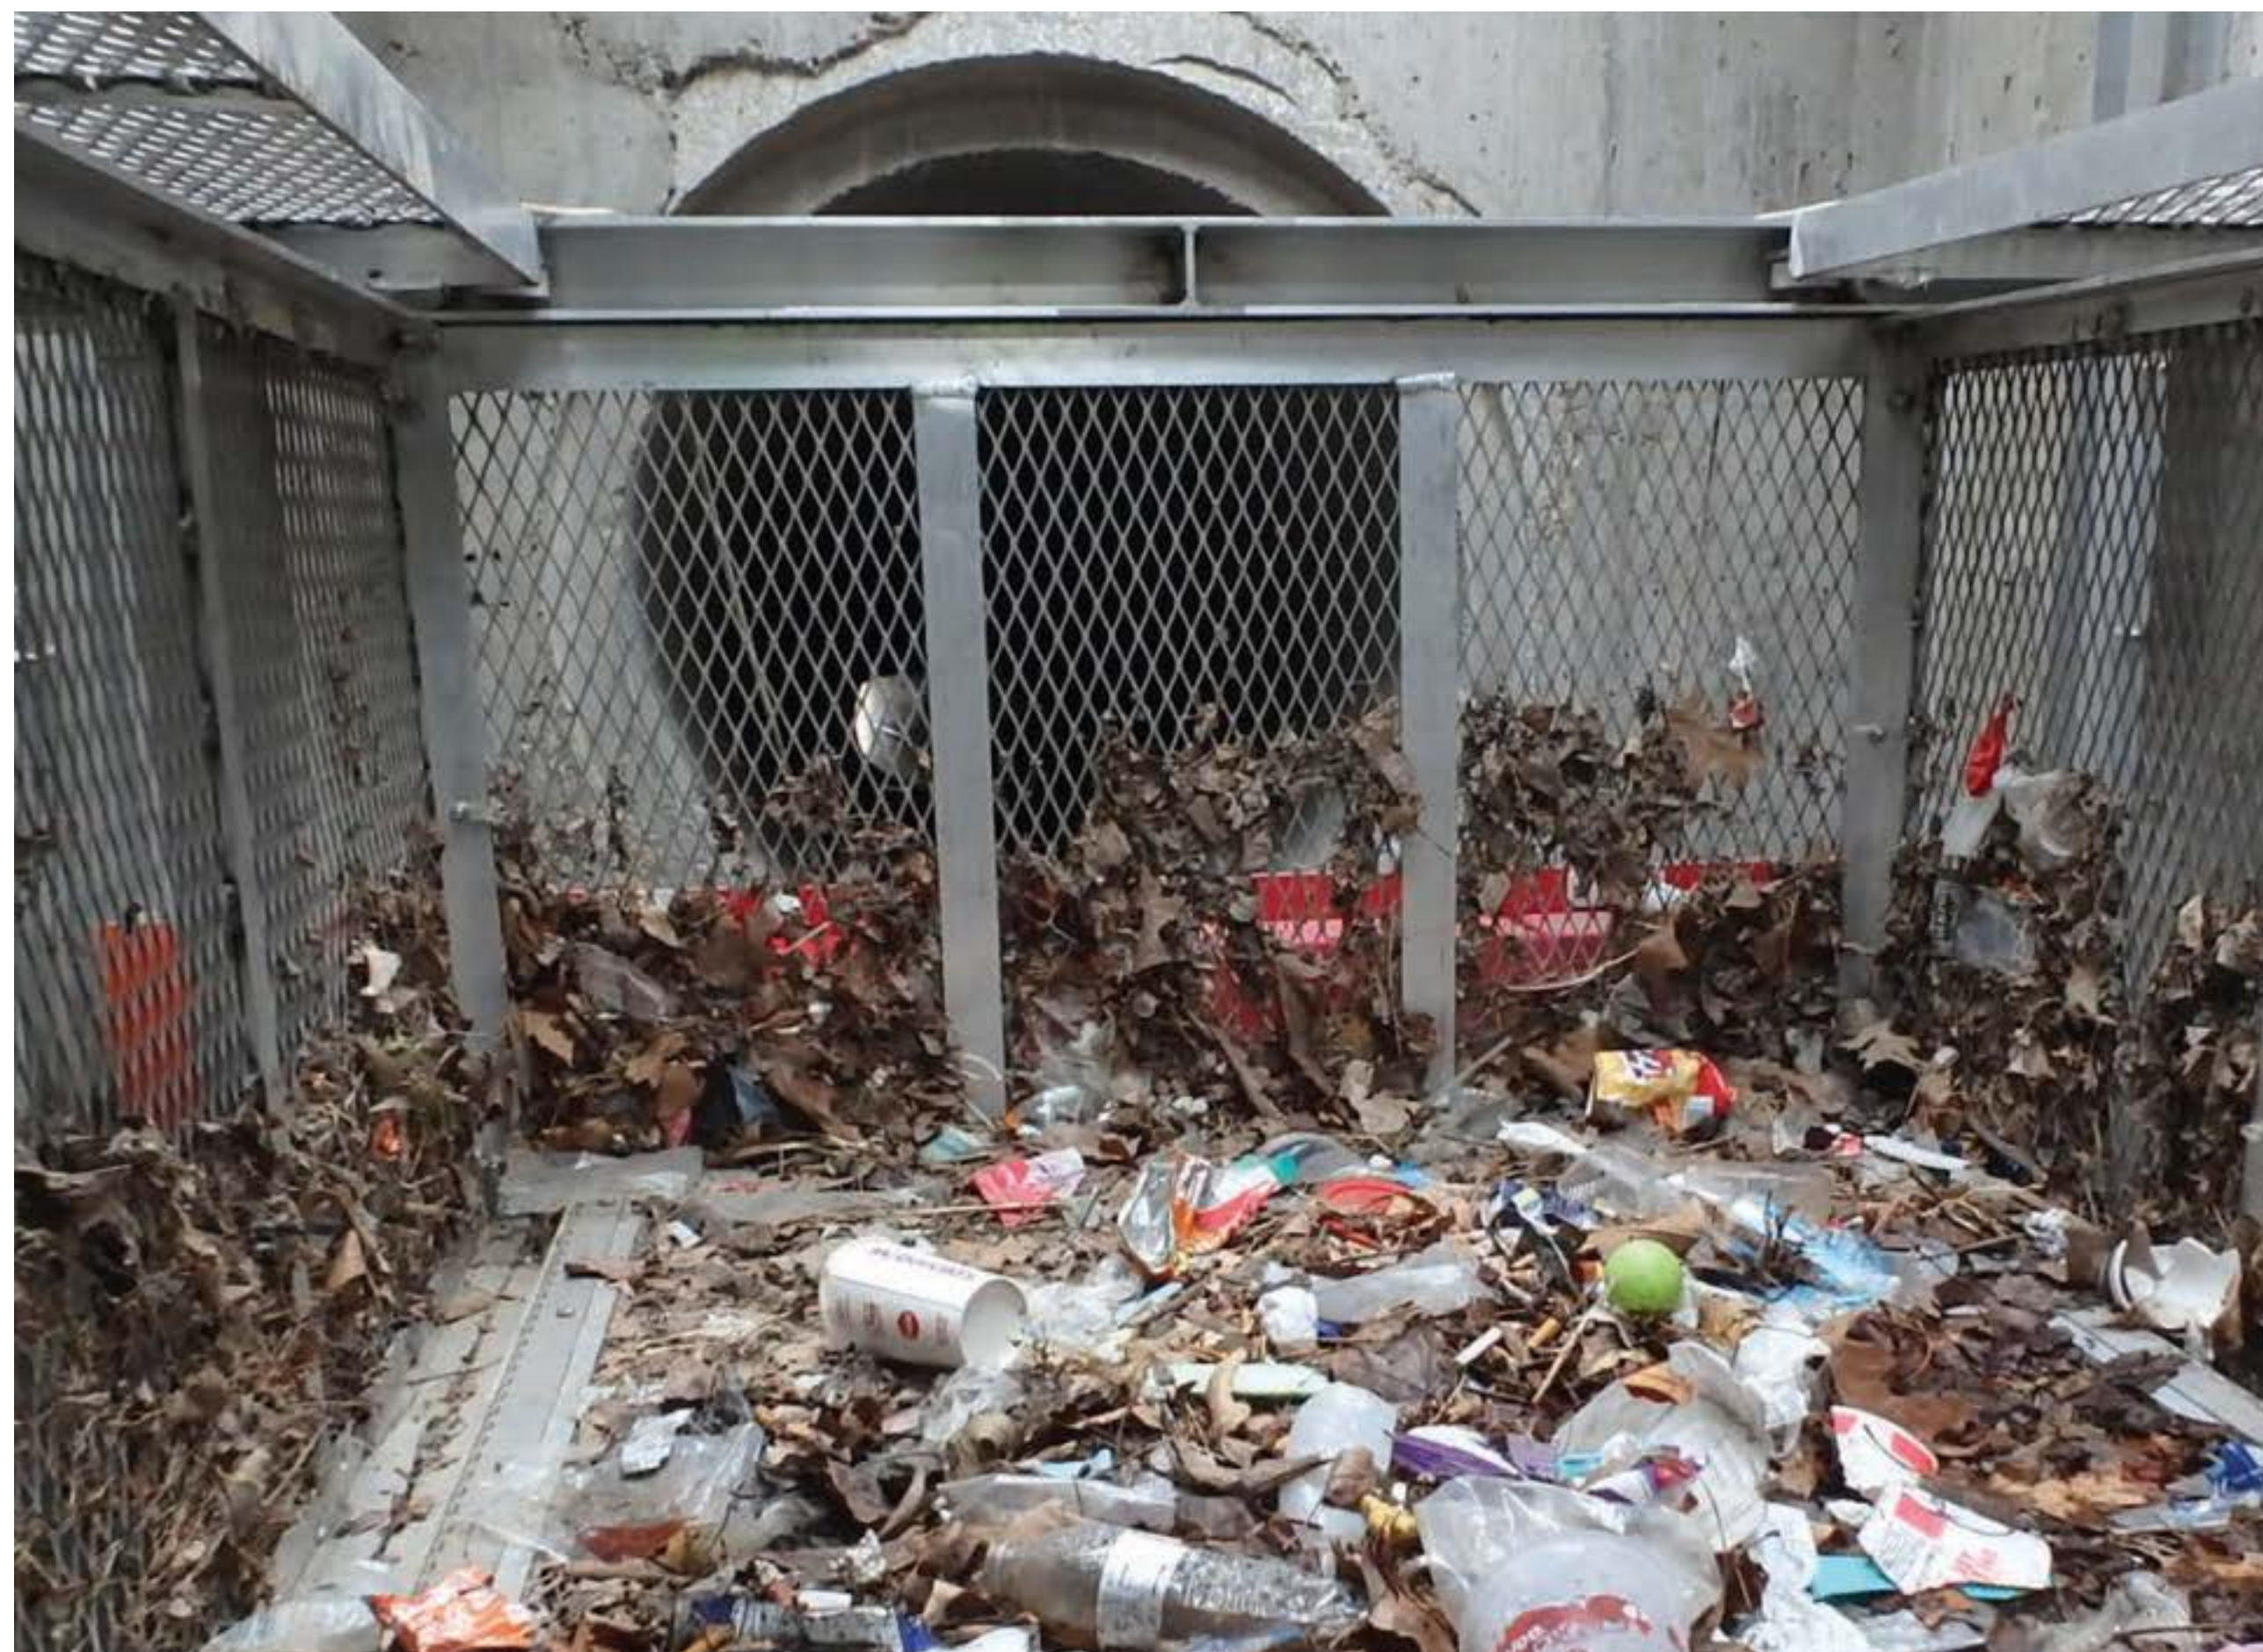
## NUTRIENT SEPARATING BAFFLE BOXES

- BOTH BOXES ARE MULTI-STAGED SELF CONTAINED TREATMENT SYSTEMS
- EACH SUBSEQUENT COMPONENT WITHIN THE SYSTEM PROTECTS PRIOR STAGES FROM CLOGGING ISSUES OR FAILURES
- THESE STAGES INCLUDE FILTRATION, HYDRODYNAMIC SEPARATION AND HYDROCARBON ABSORPTION
- REMOVAL RATES ARE 20% NITROGEN, 19% PHOSPHOROUS, 90% TSS
- THE KEY REMOVAL RATE IS SEDIMENT, AS SEDIMENT IS KNOWN TO "CARRY" OTHER POLLUTANTS FOR A RIDE
- REMOVAL OF THE VEHICLE IN THIS CASE IS ESSENTIAL TO POLLUTANT REMOVAL IN STORMWATER RUNOFF
- THESE UNITS CAPTURE THOUSANDS OF POUNDS OF DEBRIS, SEDIMENT, AND NUTRIENTS
- THE PREVIOUS OUTFALL CONFIGURATION DID NOT HAVE WATER QUALITY TREATMENT
